MLK CLEANING SERVICES LTD

## POST CLEANING REPORT

THE MANDRAKE HOTEL, 20-21 NEWMAN STREET, W1T 1PG

DATE OF CLEAN: 22.01.2024/23.01.2024

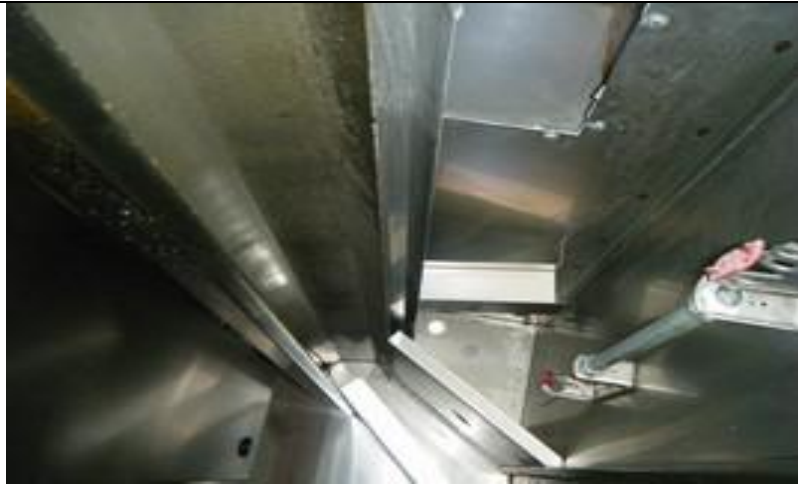
| Micron details | | Before | after |
|---|---|---|---|
| 1.CANOPY/EXTRACT PLENUM BEHIND FILTERS: | | 250 | 50 |

1 Canopy plenum before

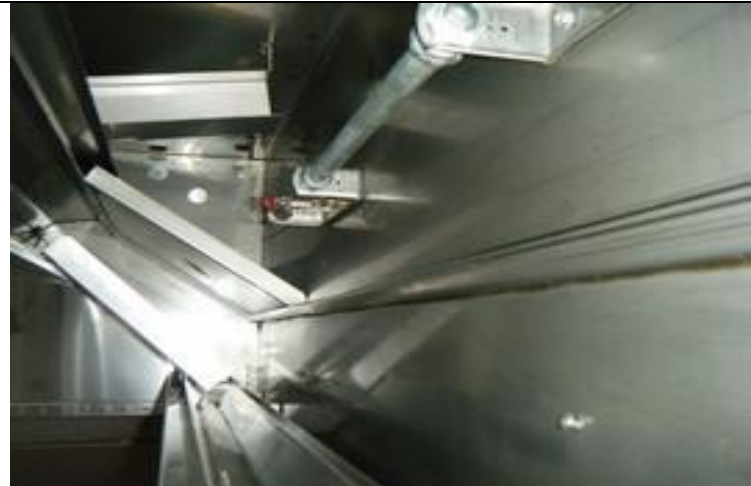
1 Canopy plenum after

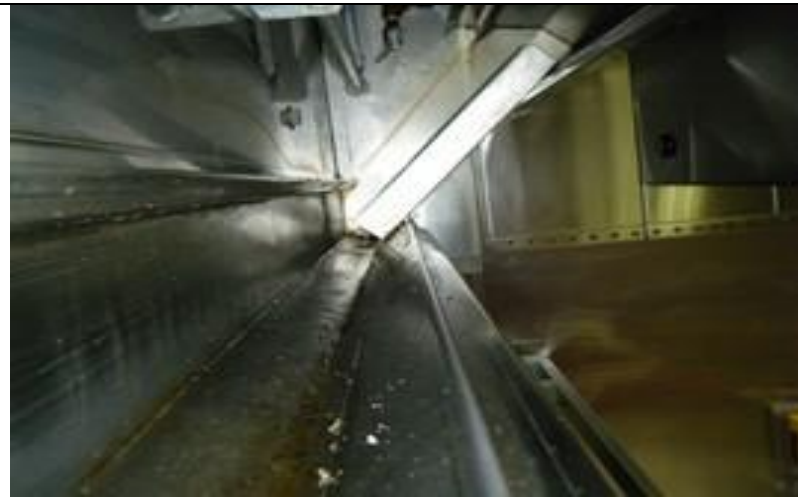
1. Canopy plenum 2, before

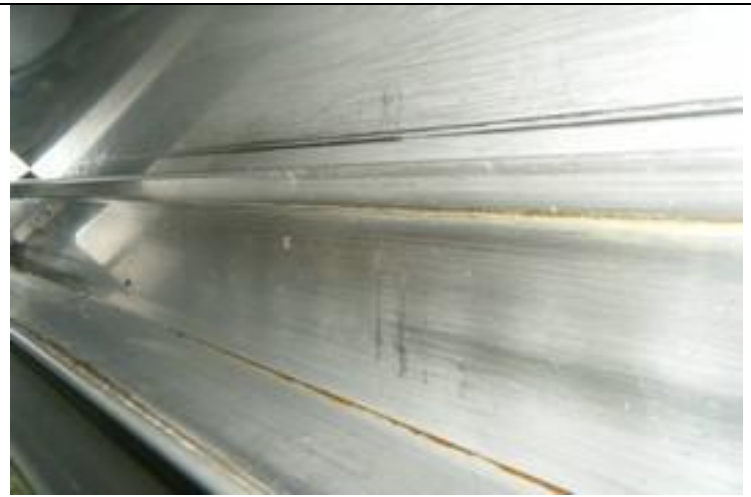
1.Canopy plenum 2, after

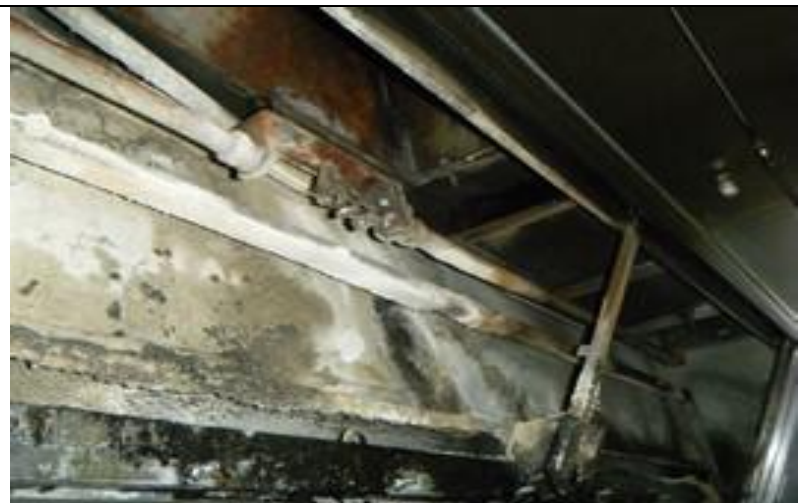
1. Canopy plenum 3 before

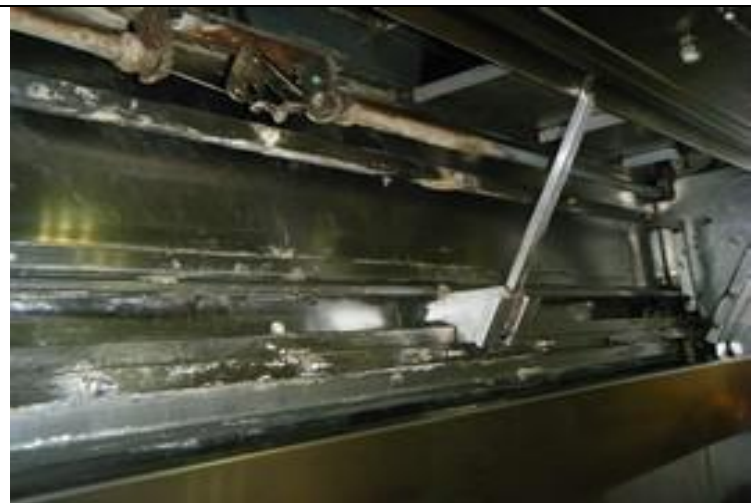
1. Canopy plenum 3 after

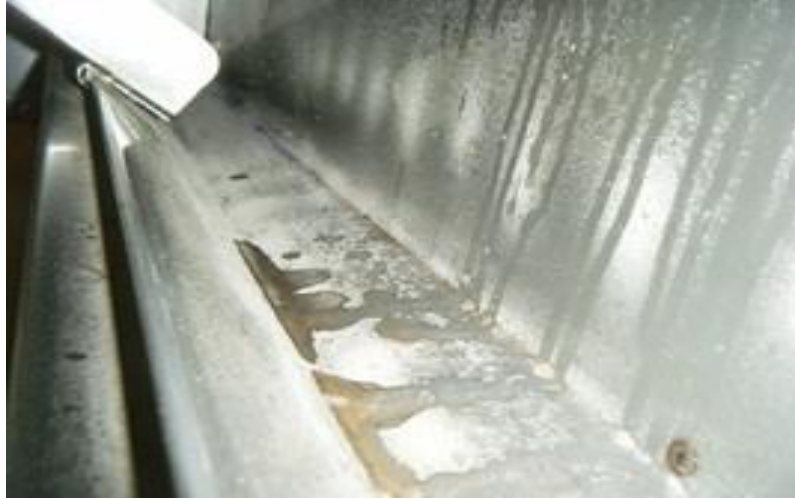
1. Canopy plenum 4 before

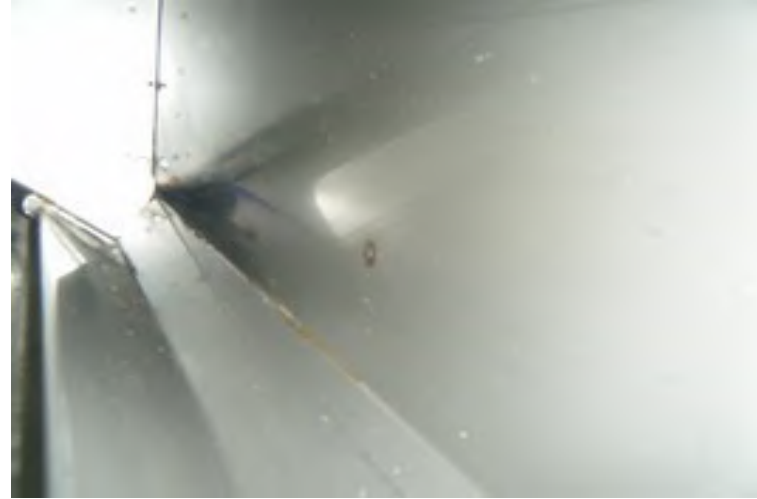
1. Canopy plenum 4 after

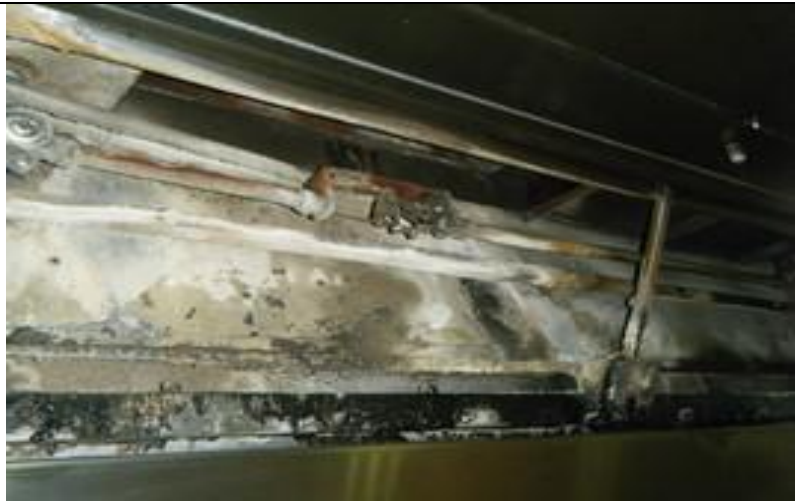
| Micron details | | Before | after |
|---|---|---|---|
| 2.DUCTWORK 1 METER FROM CANOPY: | | 200 | 50 |

2 Ductwork 1M from Canopy before

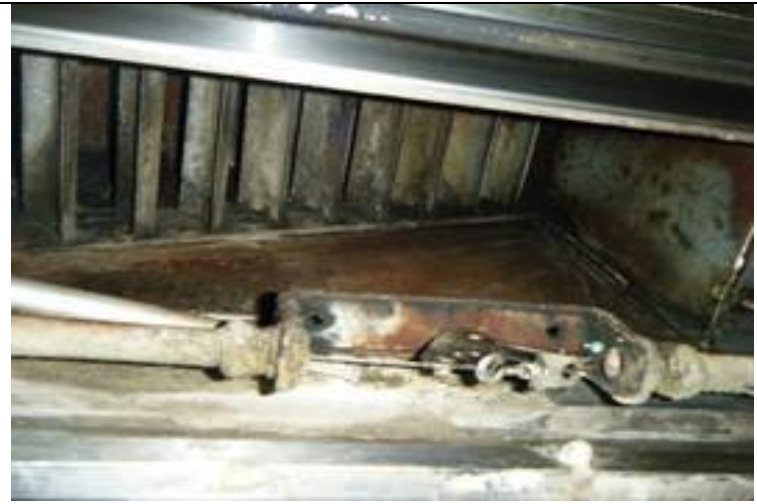
2. Ductwork 1M from Canopy after

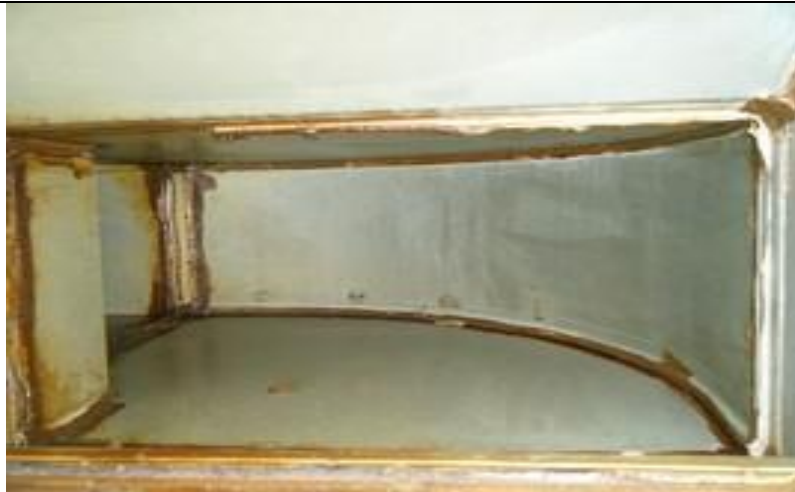
2. Ductwork 1M from Canopy 2 before

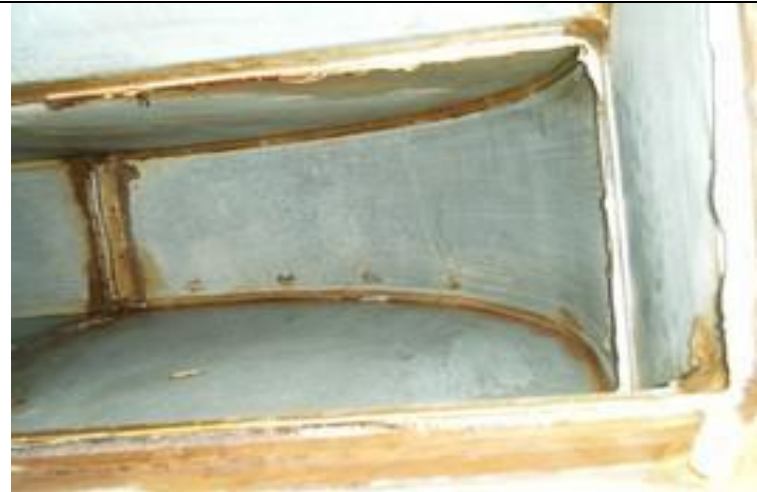
2. Ductwork 1M from Canopy 2 after

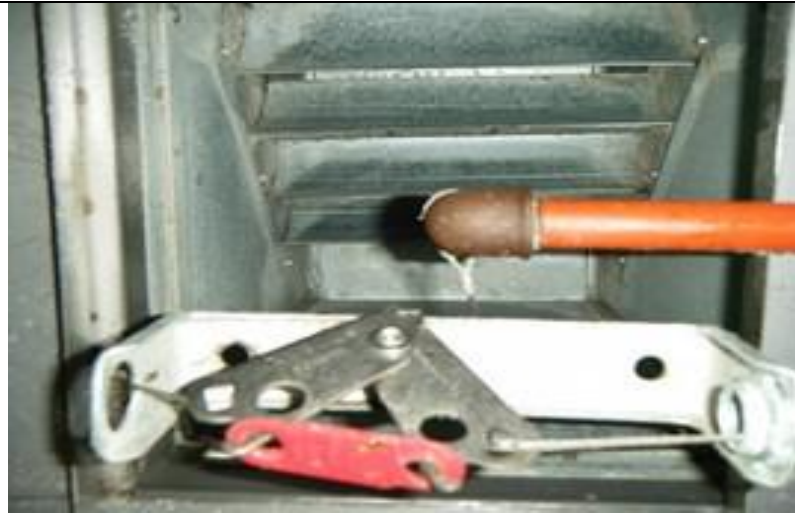
2. Ductwork 1M from Canopy 3 before

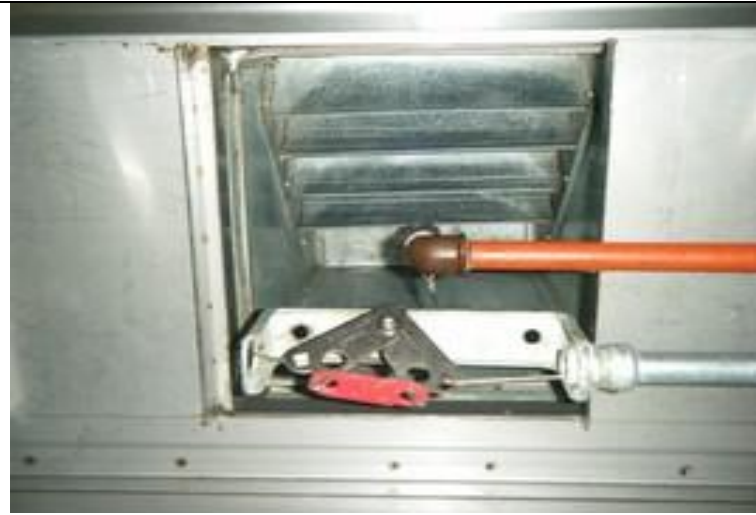
2. Ductwork 1M from Canopy 3 after

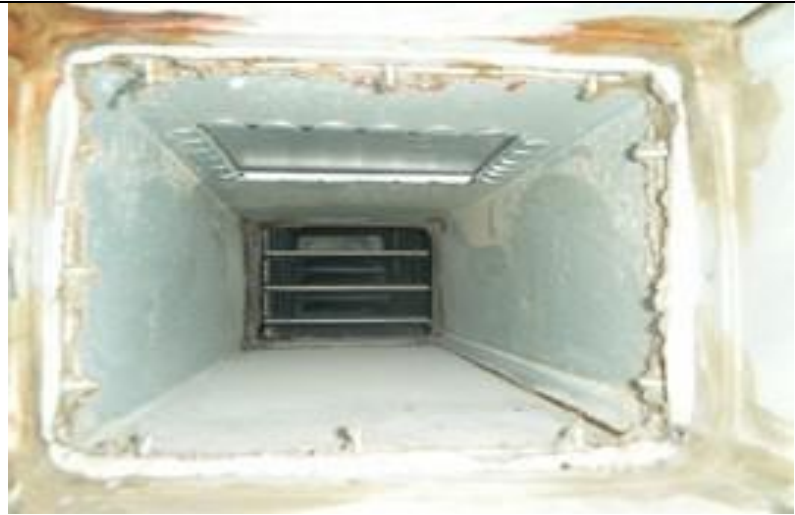
2. Ductwork 3M from Canopy 4 before

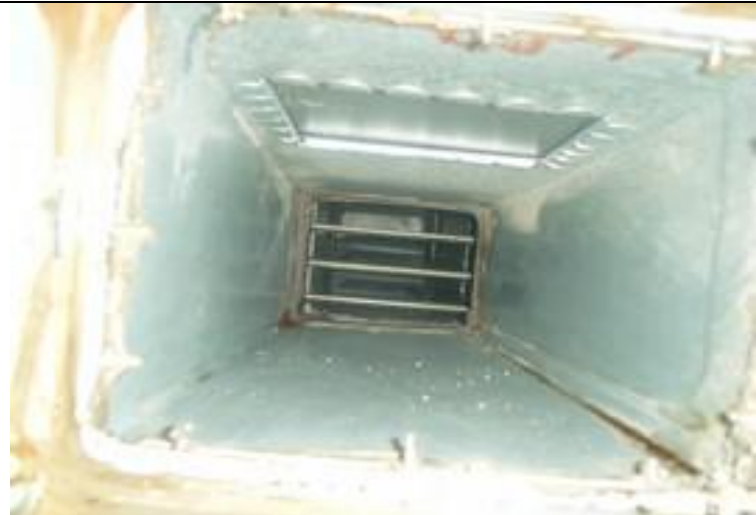
2. Ductwork 3M from Canopy 4 before

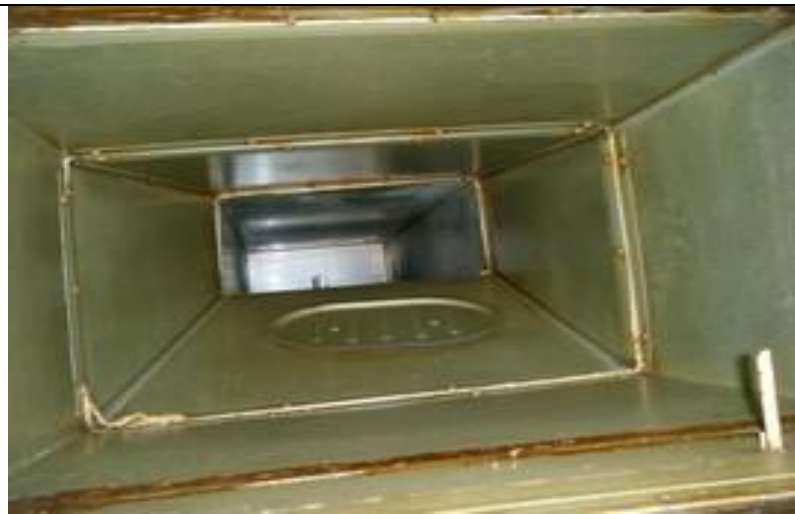
| Micron details | | Before | after |
|---|---|---|---|
| 3.DUCTWORK 3 METERS FROM CANOPY | | 200 | 50 |

3. Ductwork 3M from canopy before

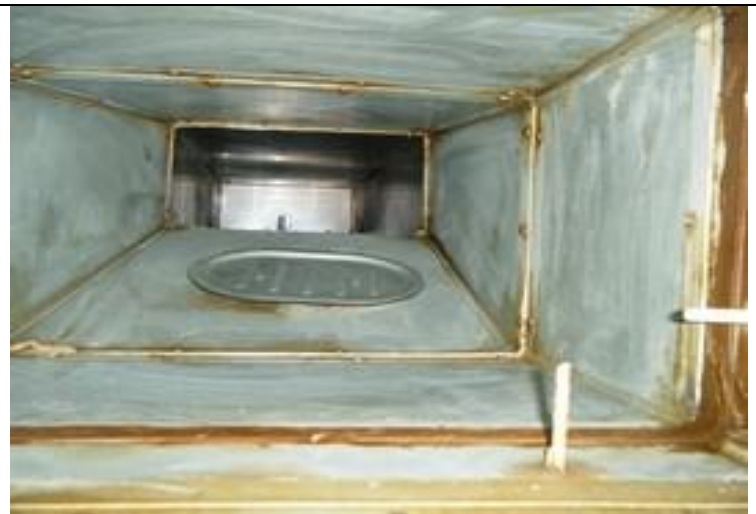
3. Ductwork 3M from canopy after

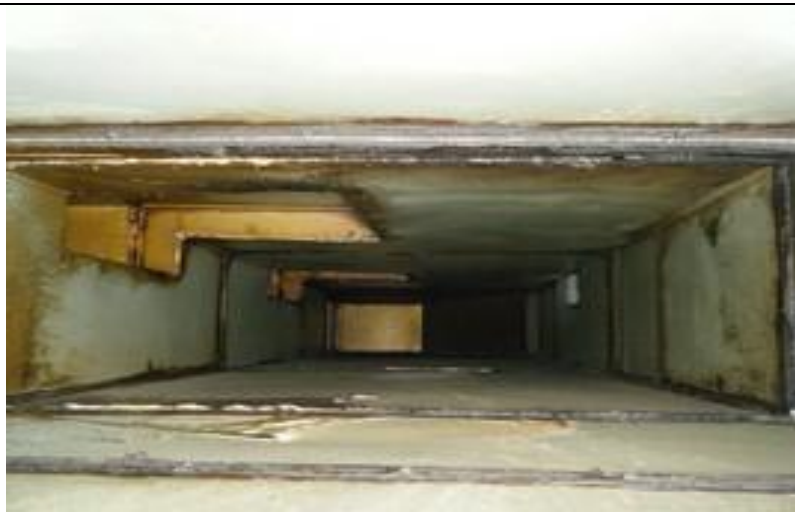
3 Ductwork 3M from canopy before

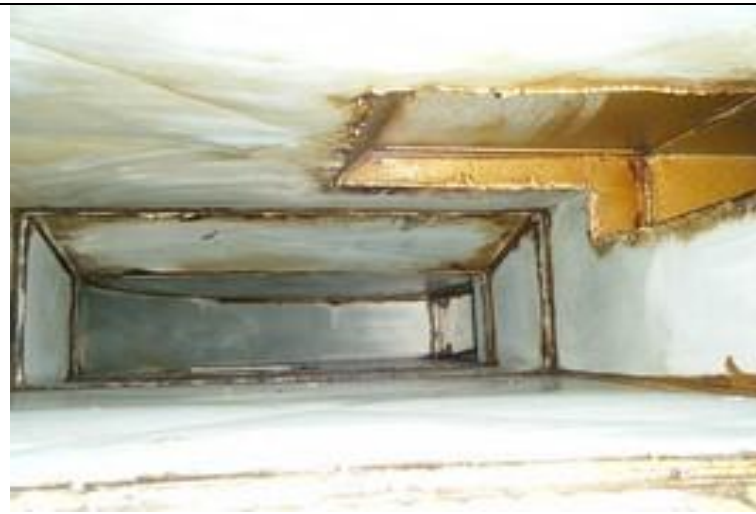
3 Ductwork 3M from canopy after

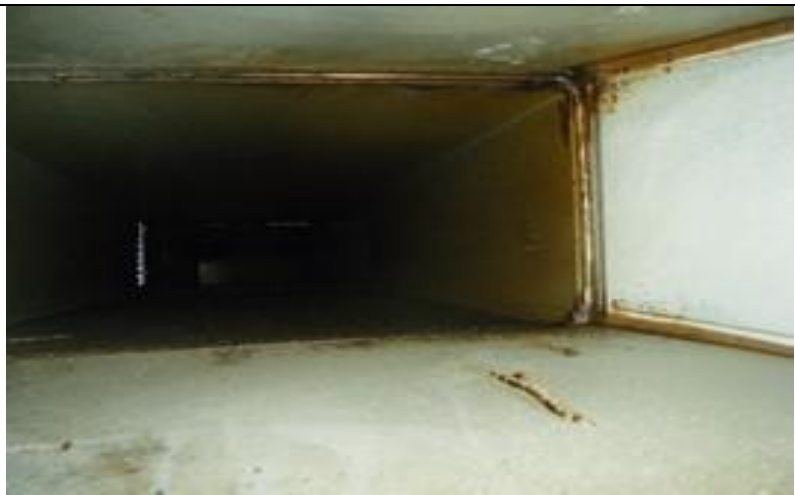
| Micron details | | Before | after |
|---|---|---|---|
| 4.DUCTWORK MIDWAY BETWEEN CANOPY AND FAN: | | 200 | 50 |

4. Ductwork Midway Between Canopy and fan before

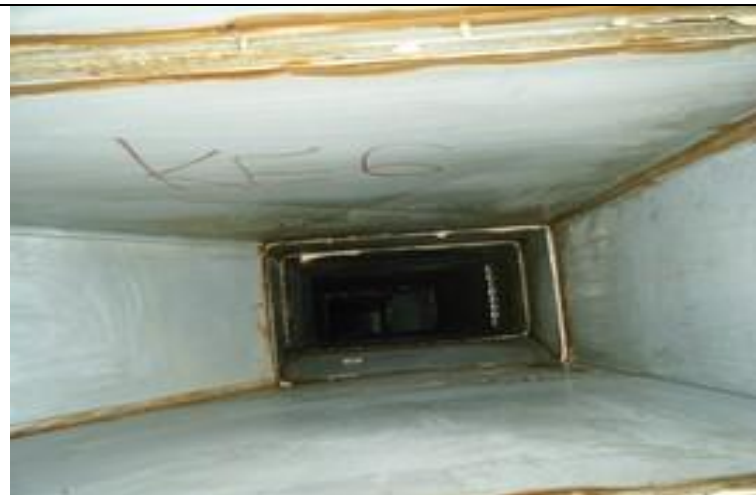
. 4. Ductwork Midway Between Canopy and fan after

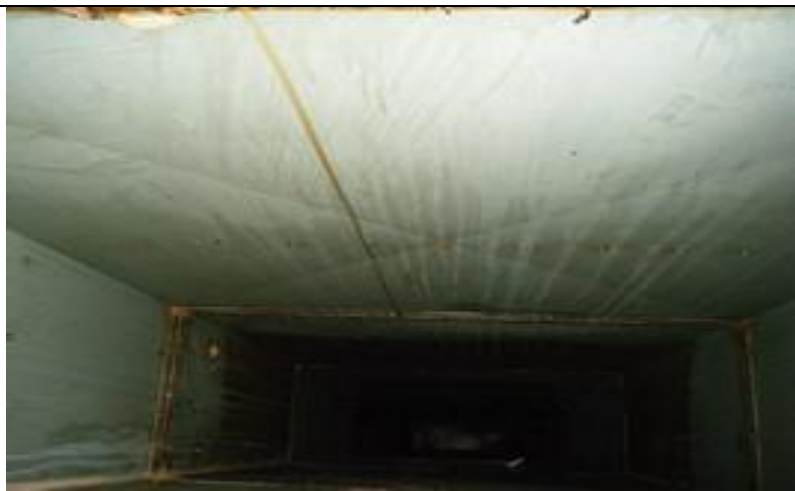
4. Ductwork Midway Between Canopy and Fan before

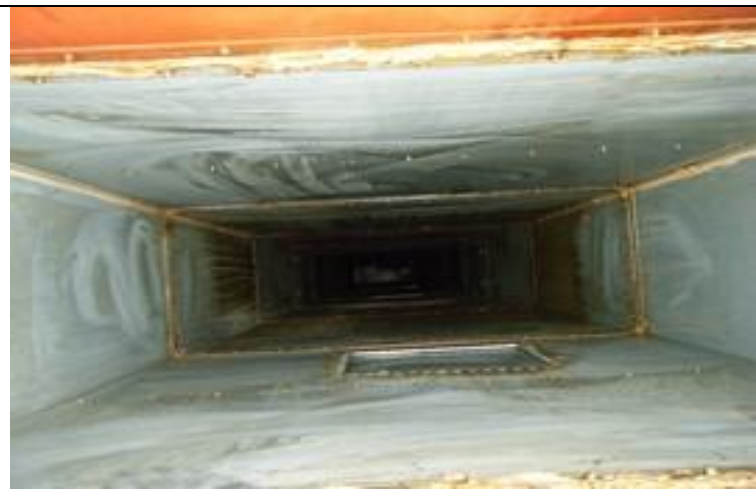
4.Ductwork Midway Between Canopy and Fan after

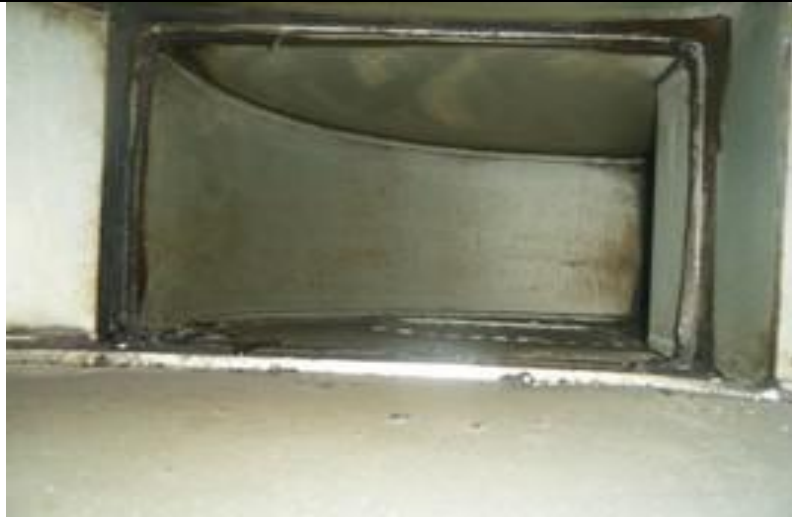
4. Ductwork Midway Between Canopy and fan before

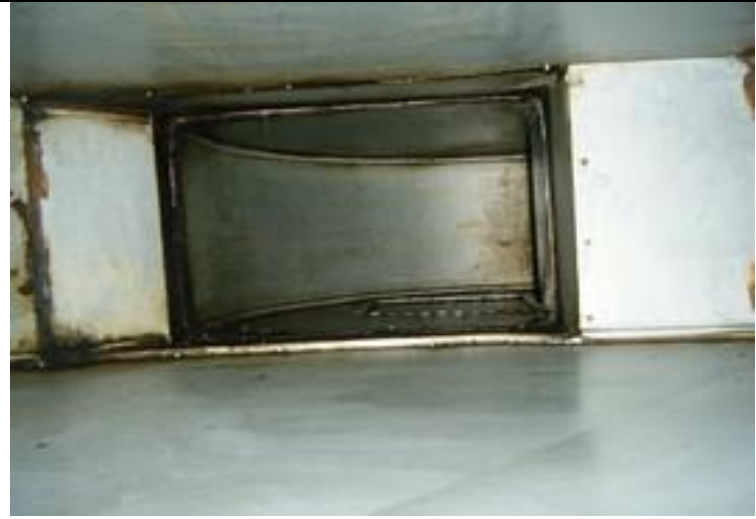
4. Ductwork Midway Between Canopy and fan after

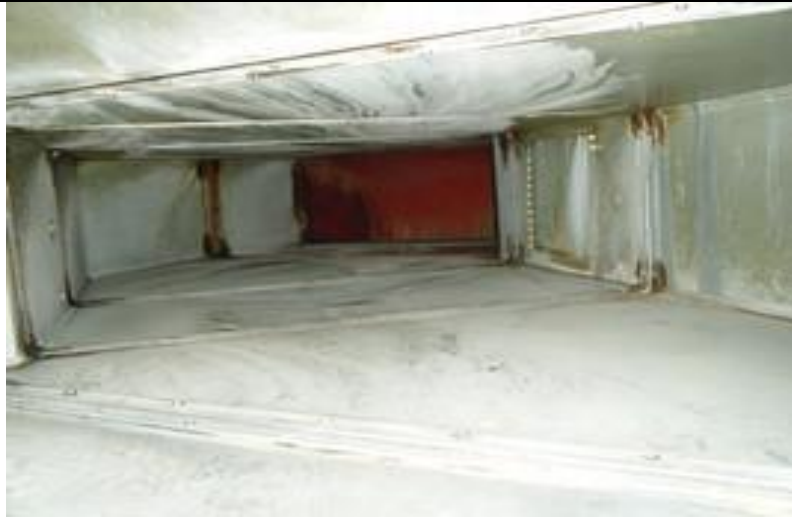
| Micron details | | Before | after |
|---|---|---|---|
| 5.DUCTWORK UPSTREAM OF FAN UNIT: | | 250 | 50 |

5. Ductwork Upstream of fan ( roof area) before

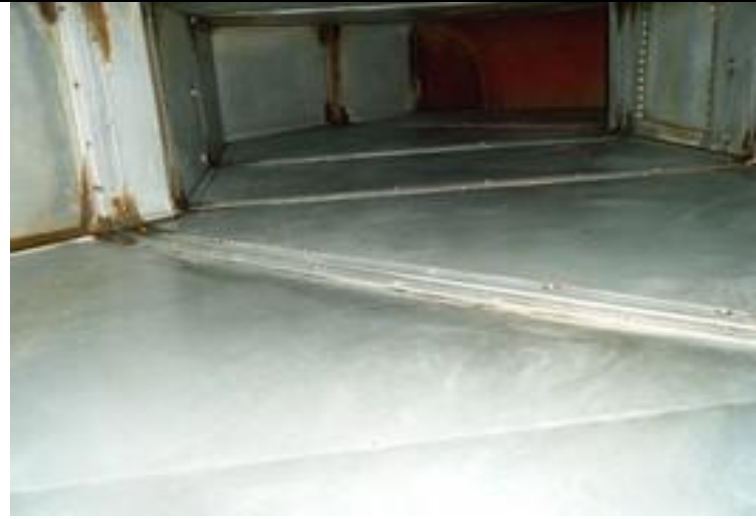
5. Ductwork Upstream of fan ( roof area) after

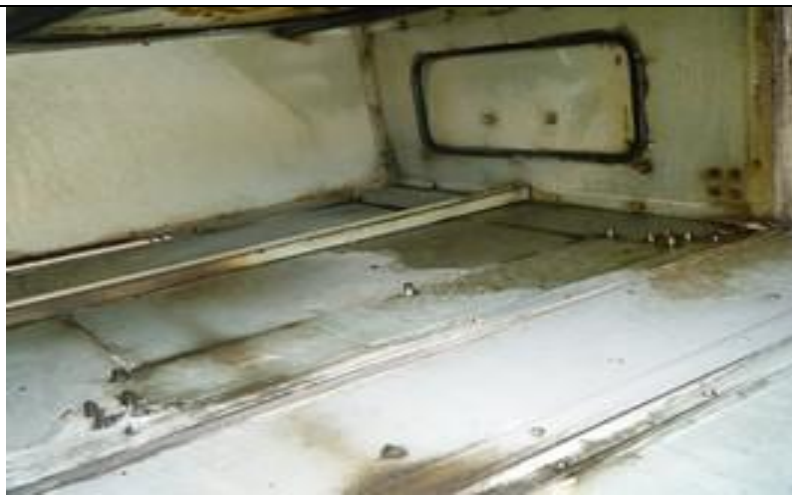
5. Ductwork Upstream of fan ( roof area) before

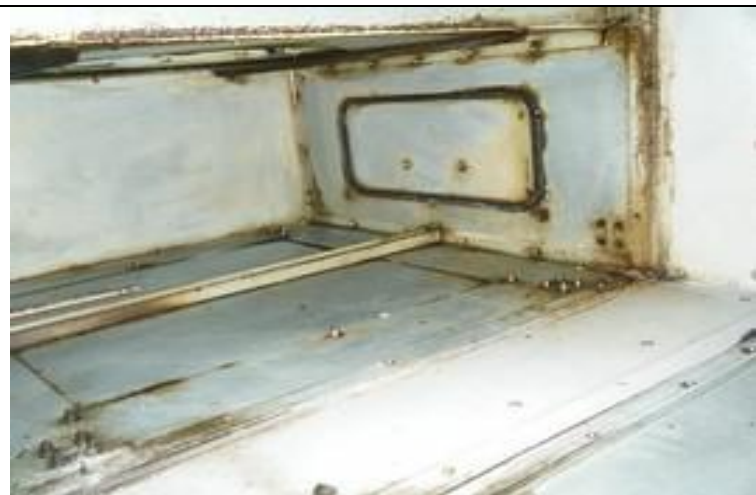
5. Ductwork Upstream of fan ( roof area) after

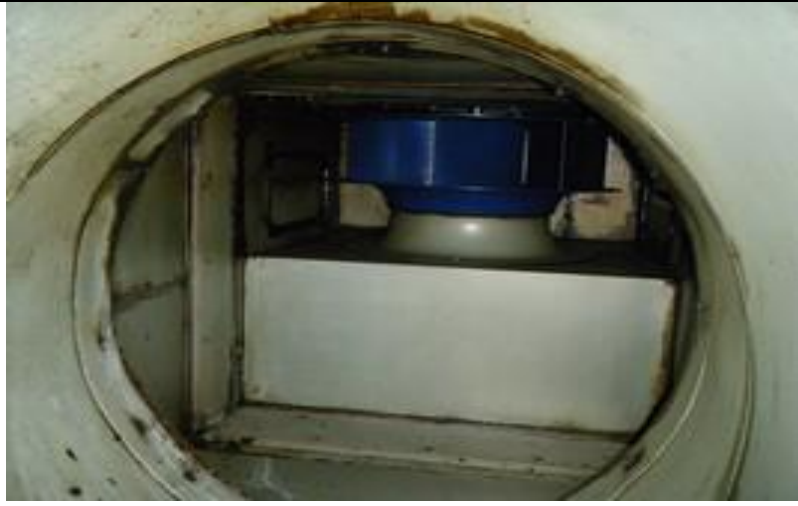
| Micron details | | Before | after |
|---|---|---|---|
| 6.FAN UNIT: | | 200 | 50 |

6.Fan Unit before

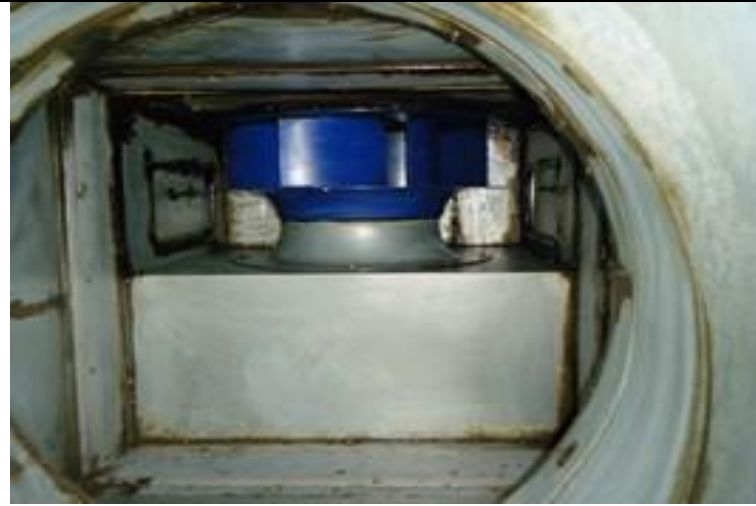
6. Fan Unit after

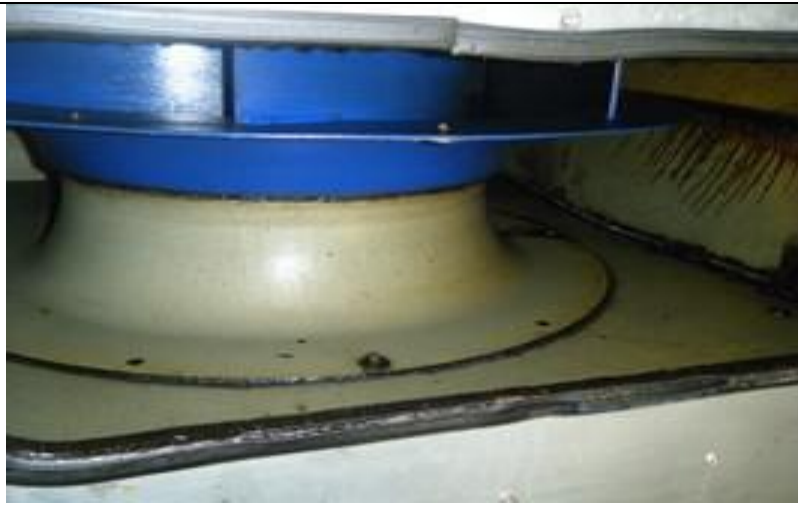
6 Fan before

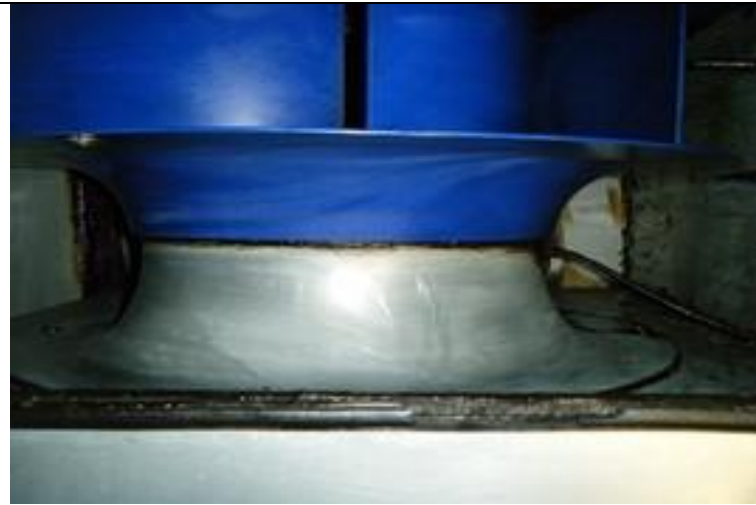
6 Fan after

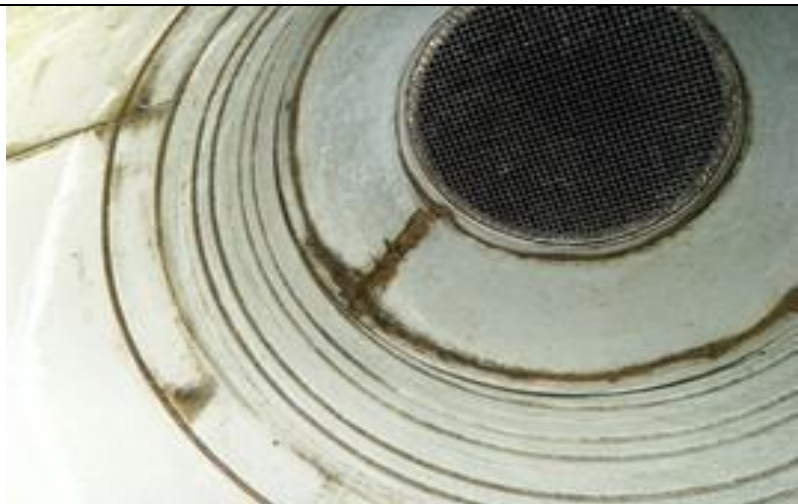
| Micron details | | Before | after |
|---|---|---|---|
| 7.DISCHARGE DUCTWORK DOWNSTREAM OF FAN | | 175 | 50 |

7. Ductwork Downstream of Fan before

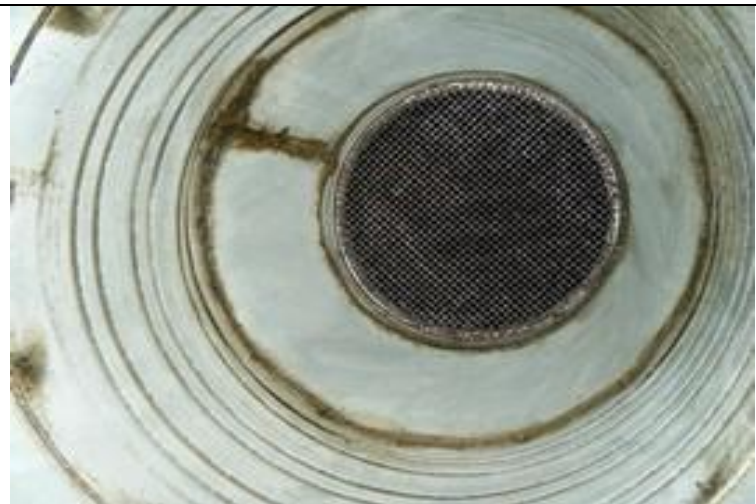
7. Ductwork Downstream of Fan after

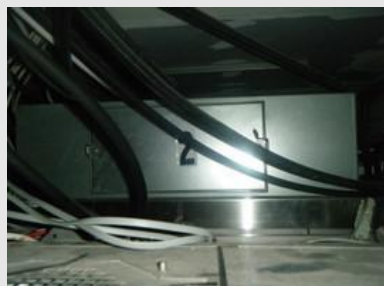
Part of duct above the canopy is not fully accessible due to space is too confined to access . Wires blocks the full access to section of duct.

BUILD UP OF GREASE WITHIN INNACCESSIBLE SECTIONS OF DUCTING POSES A POTENTIAL FIRE RISK, TO RESOLVE THIS EITHER THE SYSTEM NEEDS TO BE REDESIGNED OR STRUCTURE OF THE BUILDING MODIFIED.

TWO ACCESS PANELS ARE REQUIRED FOR KITCHEN EXTRACT ( SECTION MARKET ON DRAWING)

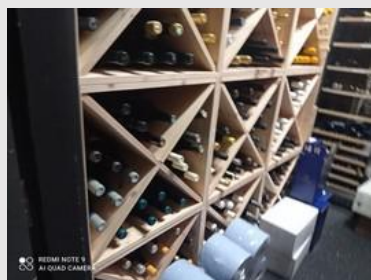
There is a section of duct blocked by the Wine Shelf in Yopo. For ductwork access, we recommend moving the shelf.
