# MLK CLEANING SERVICES LIMITED COMPANY

KERVAN SOFRASI , 80 CHURCH STREET, N9 9PB, LONDON - POST CLEANING REPORT

DATE OF CLEAN: 13.12.2024

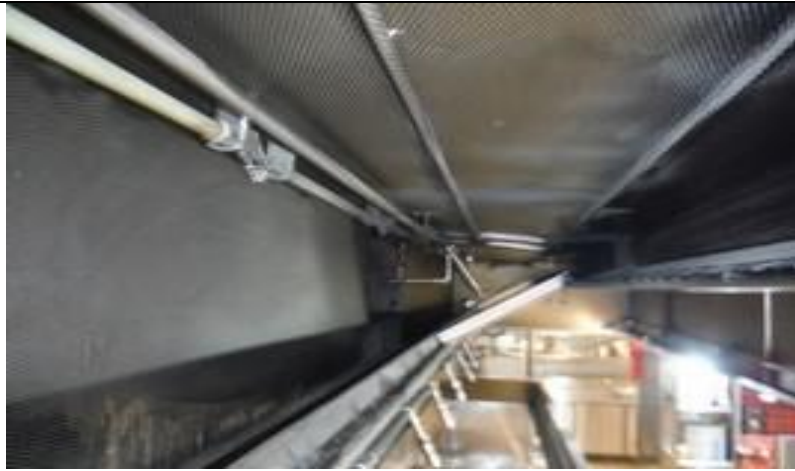
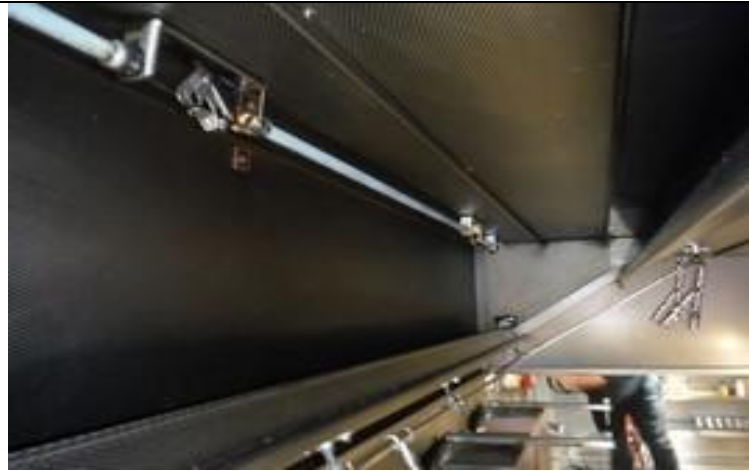
| Micron details | | Before | after |
|---|---|---|---|
| 1.CANOPY/EXTRACT PLENUM BEHIND FILTERS: | | 250 | 50 |

1 Canopy plenum (Main Extract)before

1 Canopy plenum (Main Extract) after

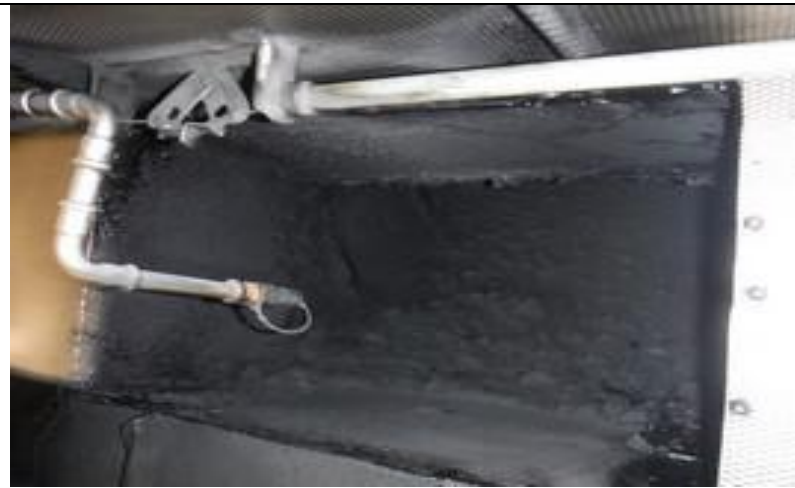
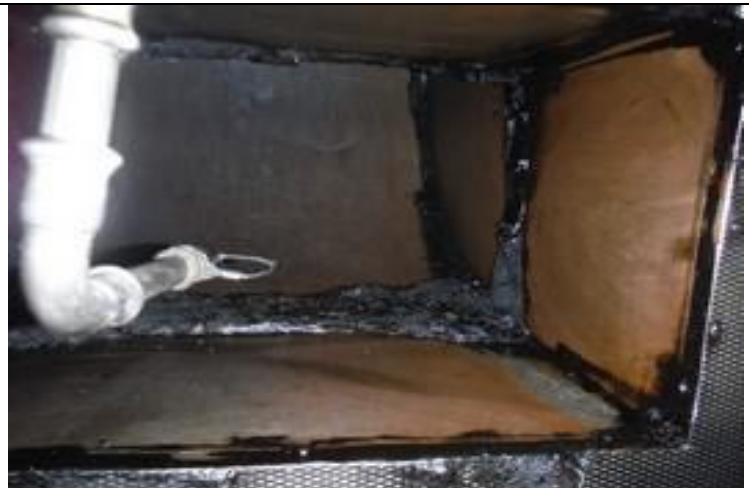
| Micron details | | Before | after |
|---|---|---|---|
| 2.DUCTWORK 1 METER FROM CANOPY: | | 250 | 50 |

2. Ductwork 1M from canopy before

2. Ductwork 1M from canopy after

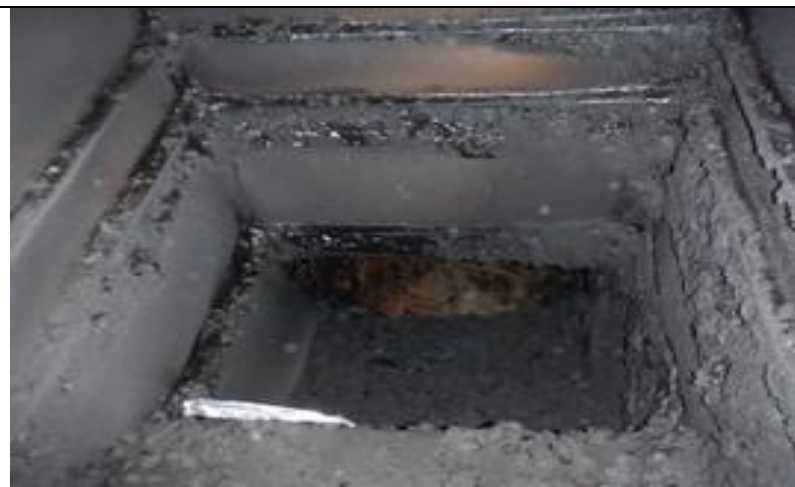
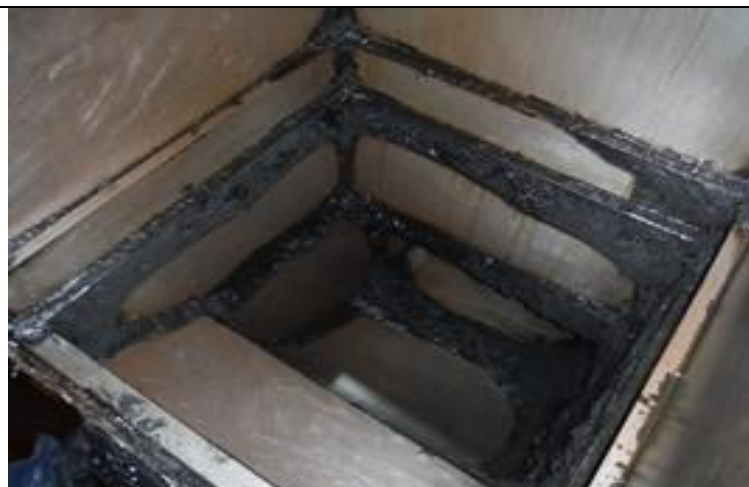
| Micron details | | Before | after |
|---|---|---|---|
| 3.DUCTWORK 3 METER FROM CANOPY: | | 200 | 50 |

3. Ductwork 3M from canopy before

3. Ductwork 3M from canopy after

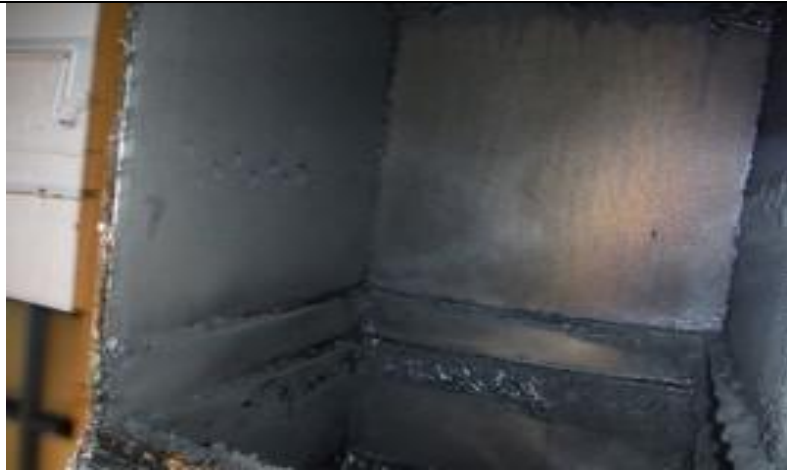
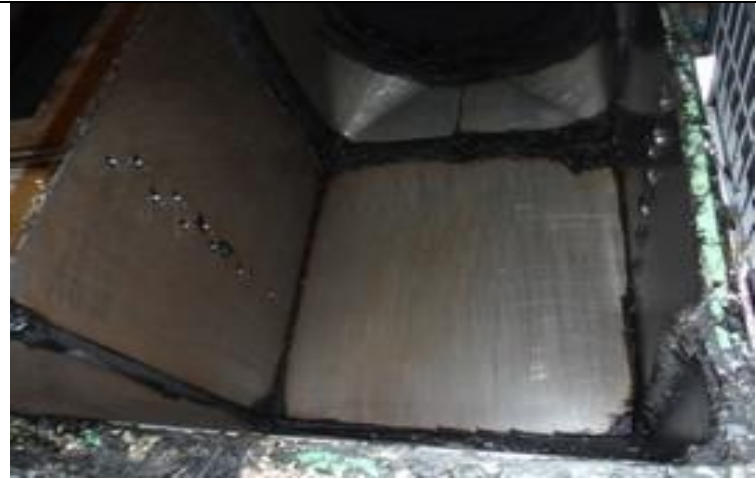
| Micron details | | Before | after |
|---|---|---|---|
| 4.DUCTWORK MIDWAY BETWEEN CANOPY AND FAN: | | 200 | 50 |

4. Ductwork Midway between canopy and fan before

4.Ductwork Midway between canopy and fan after

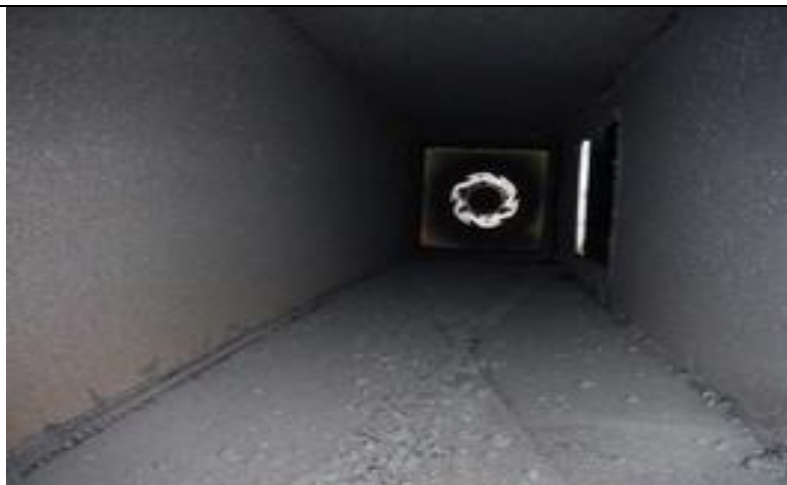
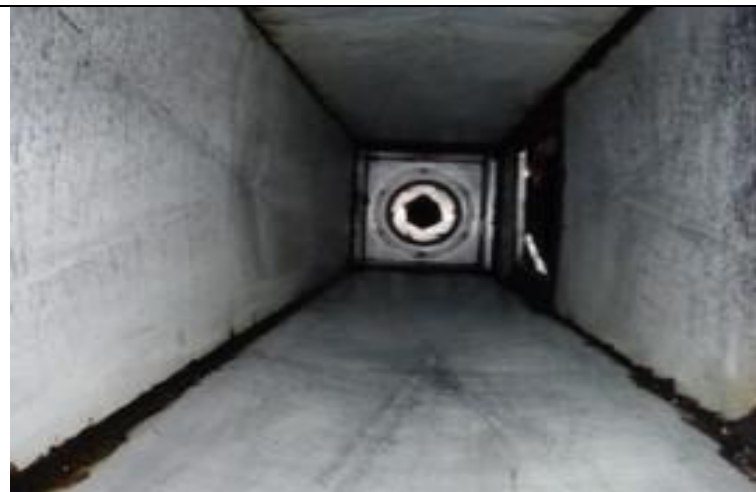
| Micron details | | Before | after |
|---|---|---|---|
| 5.DUCTWORK UPSTREAM OF FAN UNIT: | | 200 | 50 |

5.Ductwork Upstream of Fan before

5. Ductwork Upstream of Fan after

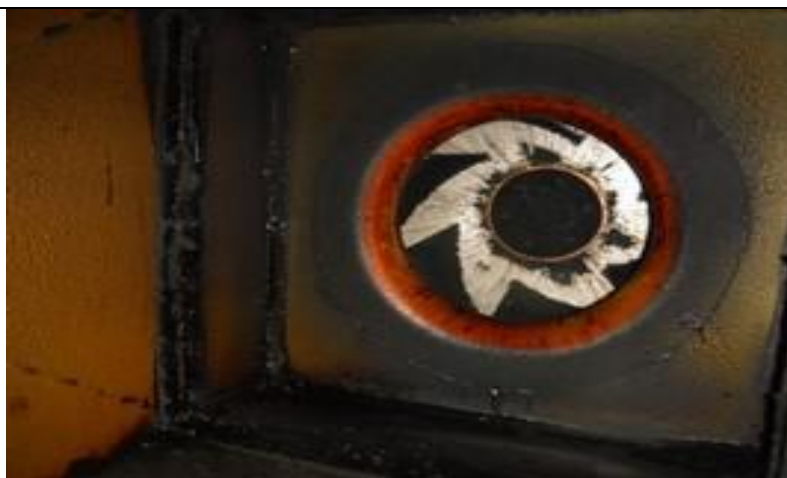
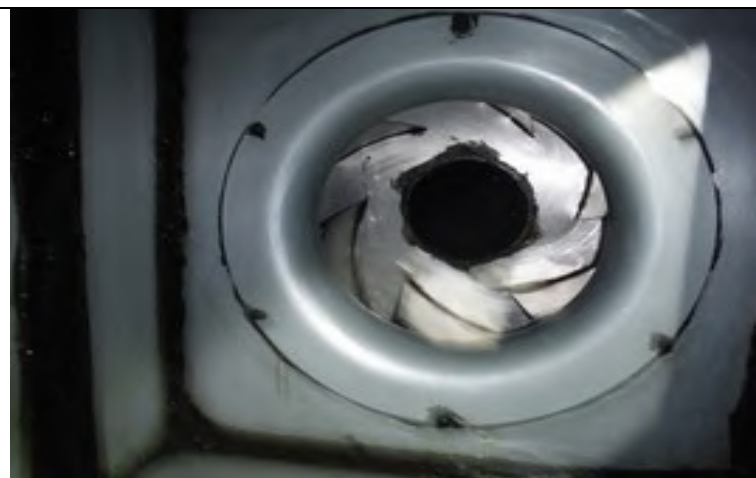
6. Fan Intake before

6. Fan Intake after

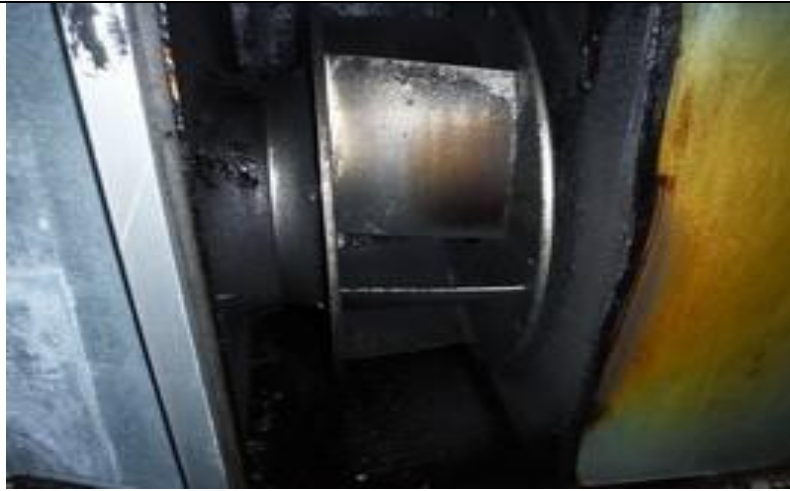
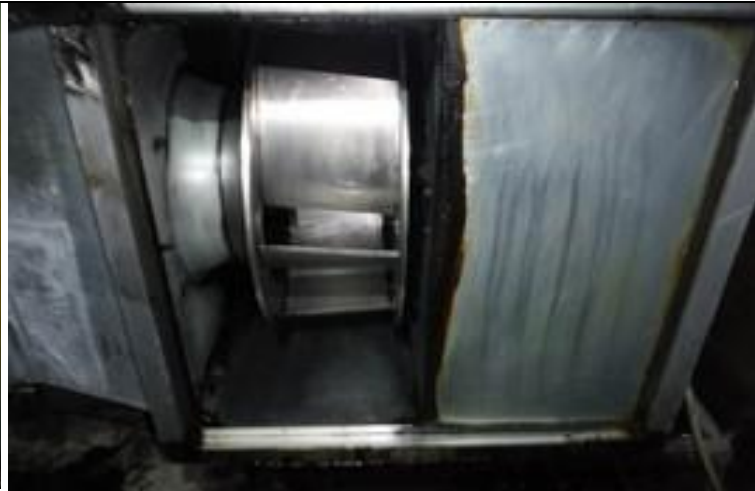
| Micron details | | Before | after |
|---|---|---|---|
| 6.FAN UNIT: | | 200 | 50 |

6.Fan before

6. Fan after

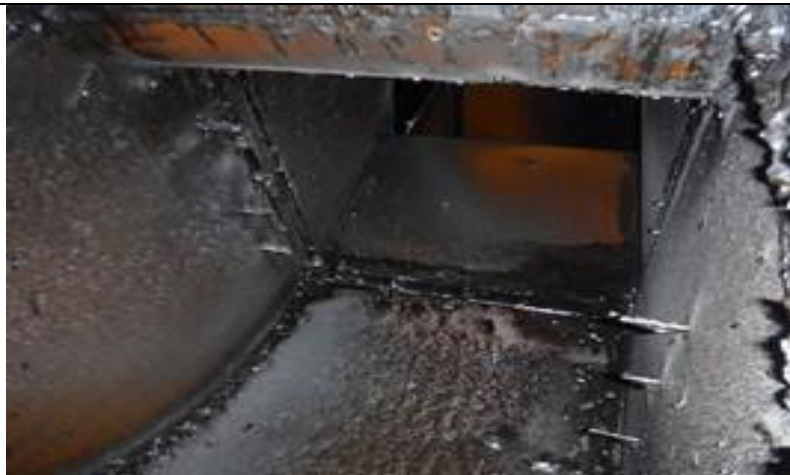
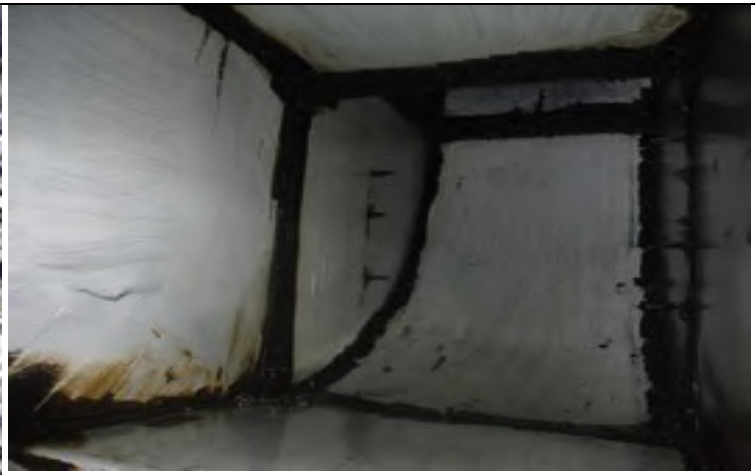
| Micron details | | Before | after |
|---|---|---|---|
| 7.DISCHARGE DUCTWORK DOWNSTREAM OF FAN | | 200 | 50 |

7. Duct above the fan before

7. Duct abvoce the fan after

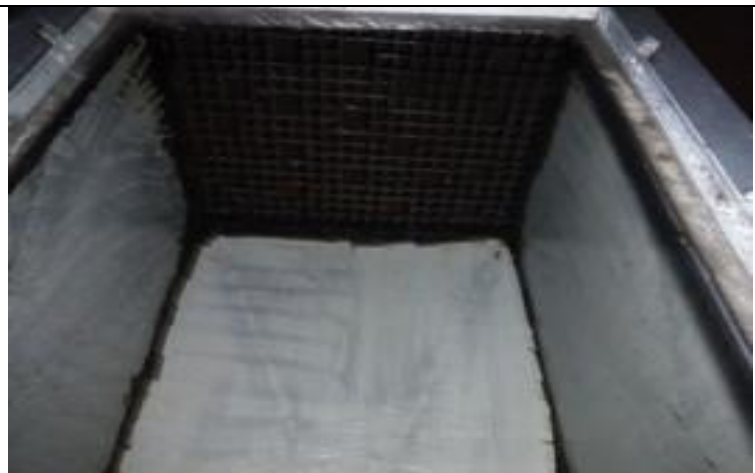
7. Duct above the fan before

7. Duct abvoce the fan after

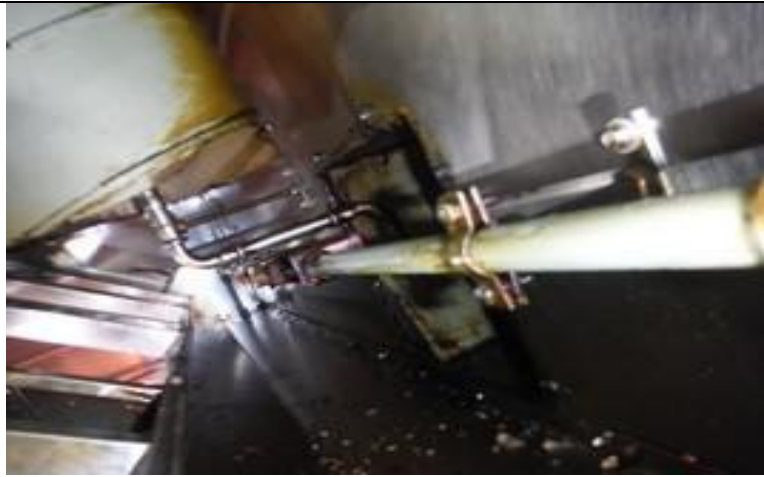
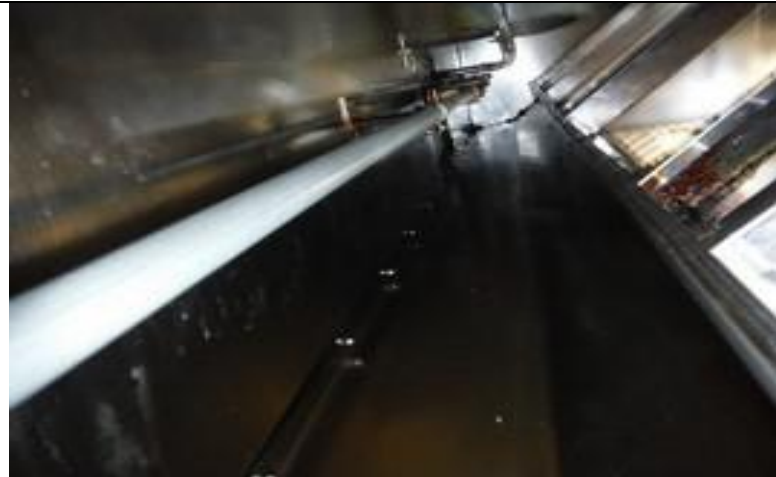
| Micron details | | Before | after |
|---|---|---|---|
| 1.CANOPY/EXTRACT PLENUM BEHIND FILTERS: | | 200 | 50 |

1 Canopy plenum (2<sup>nd</sup> Extract)before

1 Canopy plenum (2<sup>nd</sup> extract) after

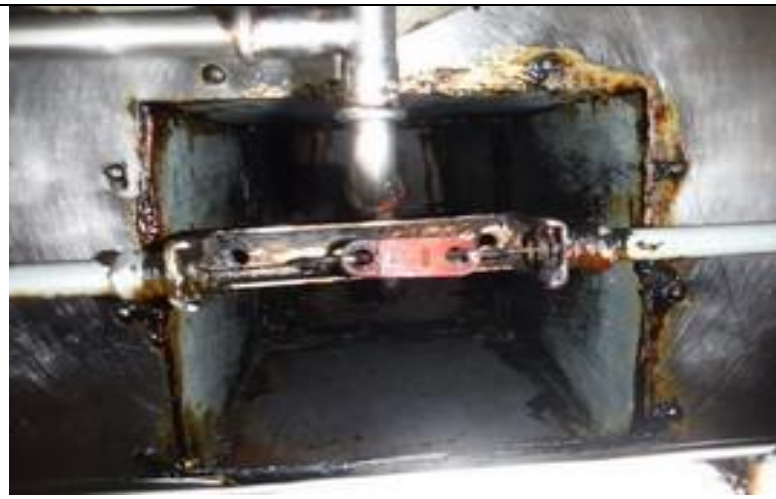
| Micron details | | Before | after |
|---|---|---|---|
| 2.DUCTWORK 1 METER FROM CANOPY: | | 200 | 50 |

2. Ductwork 1M from canopy before

2. Ductwork 1M from canopy after

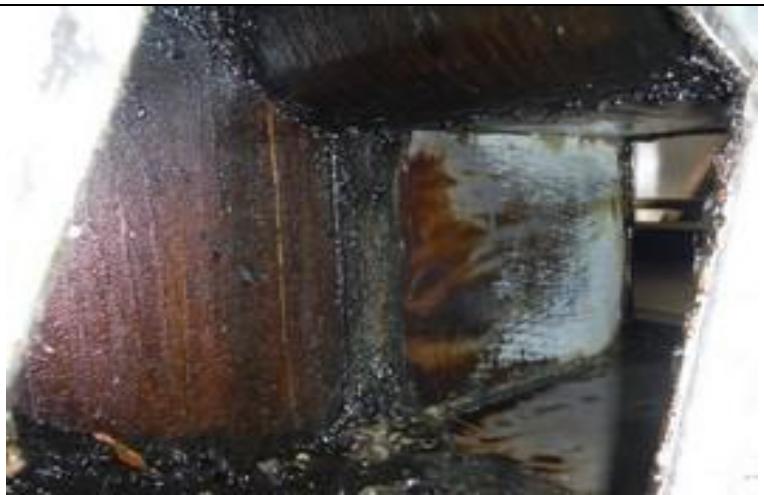
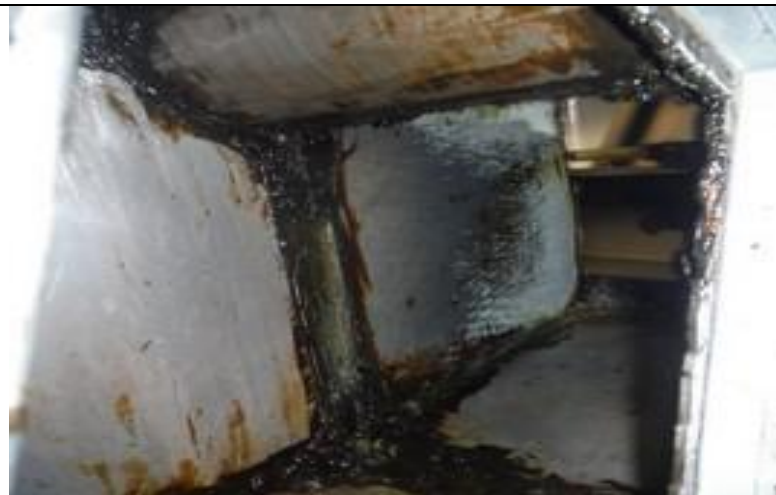
| Micron details | | Before | after |
|---|---|---|---|
| 4.DUCTWORK MIDWAY BETWEEN CANOPY AND FAN: | | 200 | 50 |

4 Ductwork Midway between canopy and fan before

4 Ductwork Midway between canopy and fan after

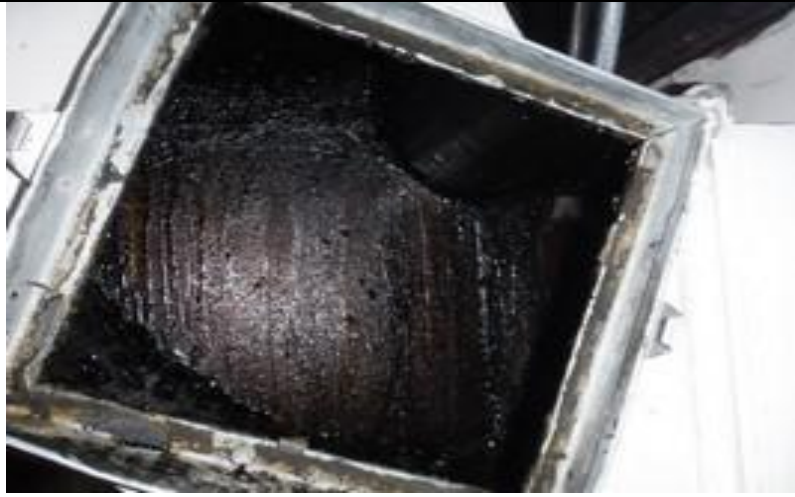
| Micron details | | Before | after |
|---|---|---|---|
| 5.DUCTWORK UPSTREAM OF FAN UNIT: | | 200 | 50 |

5. Ductwork Upstream of Fan before

5 Ductwork Upstream of Fan After

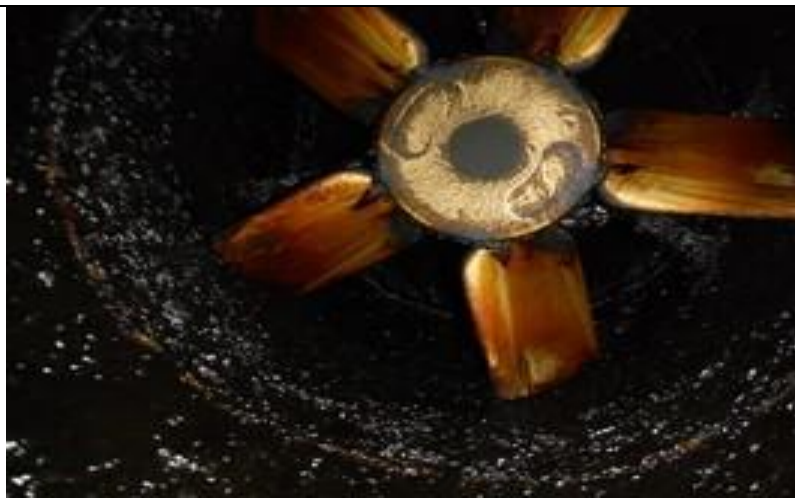
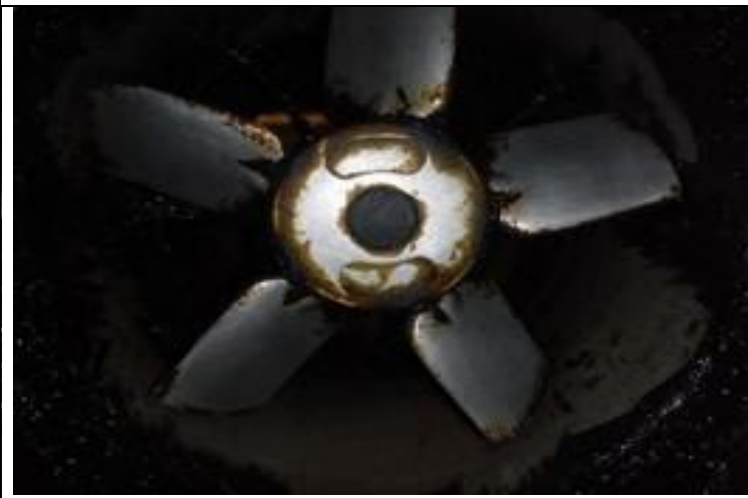
| Micron details | | Before | after |
|---|---|---|---|
| 6.FAN UNIT: | | 250 | 50 |

6. Fan Unit before

6. Fan Unit after

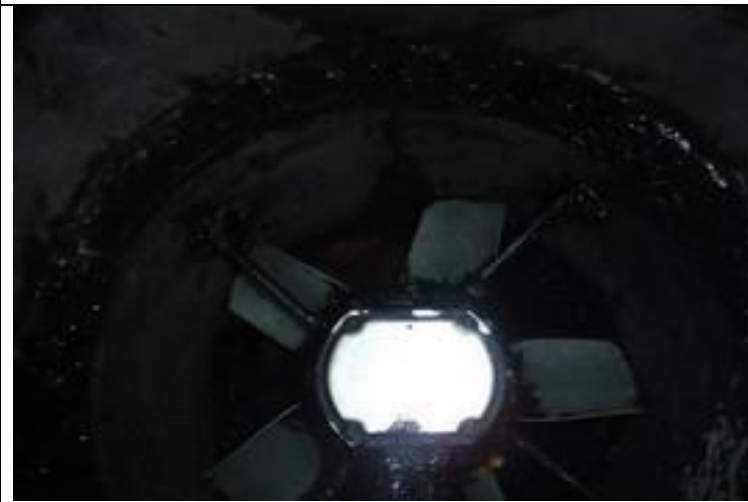
| Micron details | | Before | after |
|---|---|---|---|
| 7.DISCHARGE DUCTWORK DOWNSTREAM OF FAN | | 200 | 50 |

7. Ductwork Downstream of Fan before

7. Ductwork Downstream of Fan after

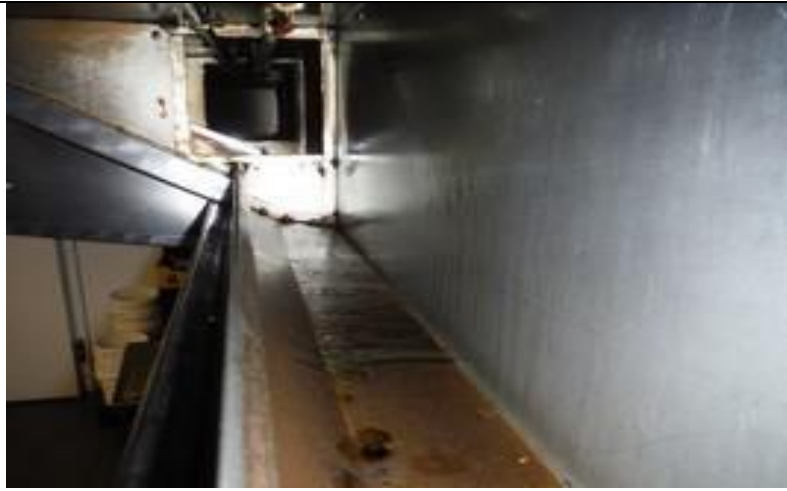
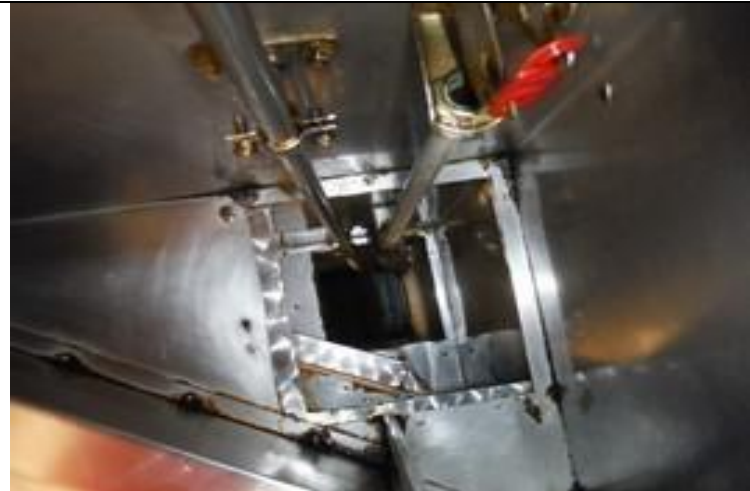
| Micron details | | Before | after |
|---|---|---|---|
| 1.CANOPY/EXTRACT PLENUM BEHIND FILTERS: | | 150 | 50 |

1.Canopy plenum (Basement Extract)before

1. Canopy plenum (Basement Extract) Afer

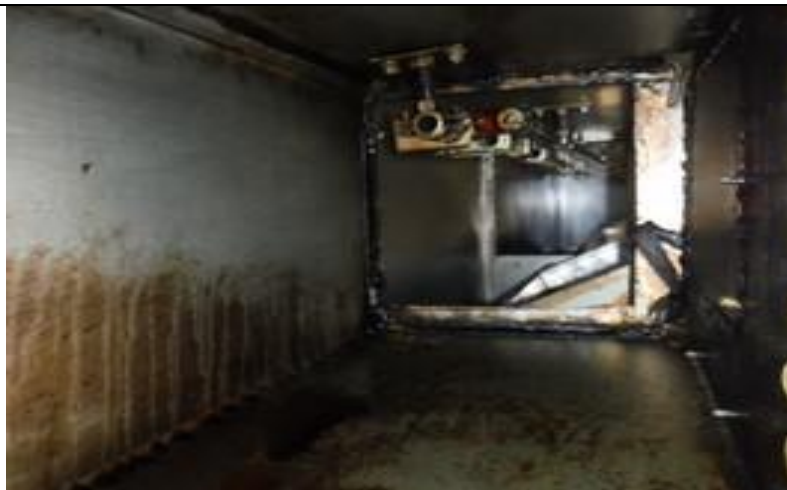
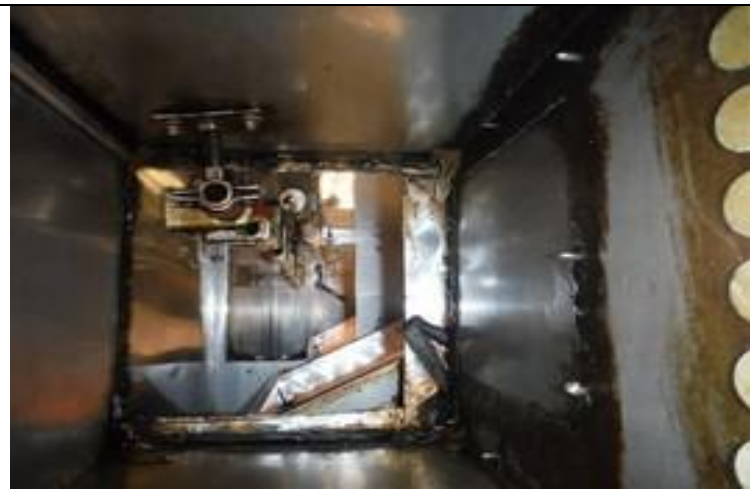
| Micron details | | Before | after |
|---|---|---|---|
| 2.DUCTWORK 1 METER FROM CANOPY: | | 200 | 50 |

2. Ductwork 1M from canopy before

2.Ductwork 1M from canopy after

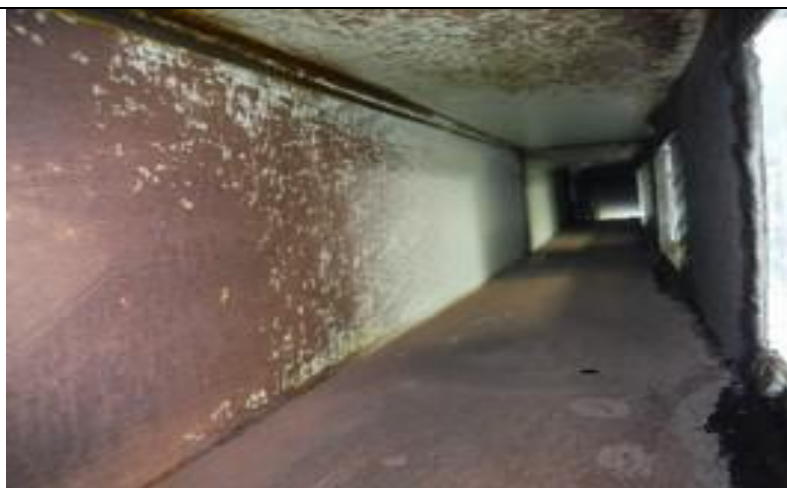
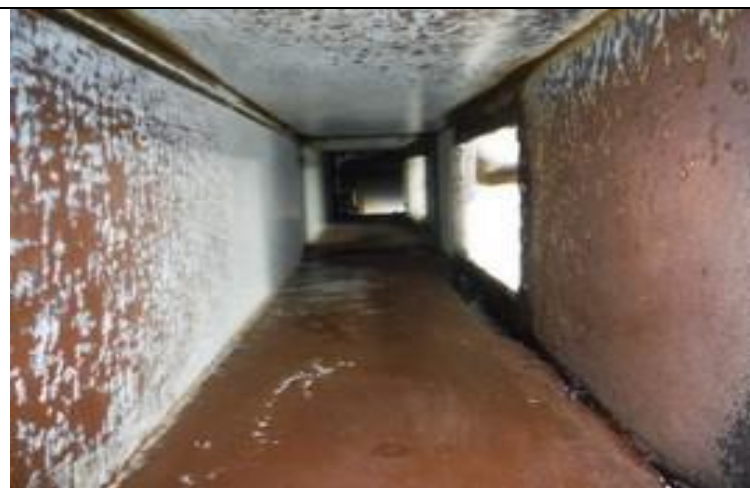
3. Ductwork 3M from canopy before

3. Ductwork 3M from canopy after

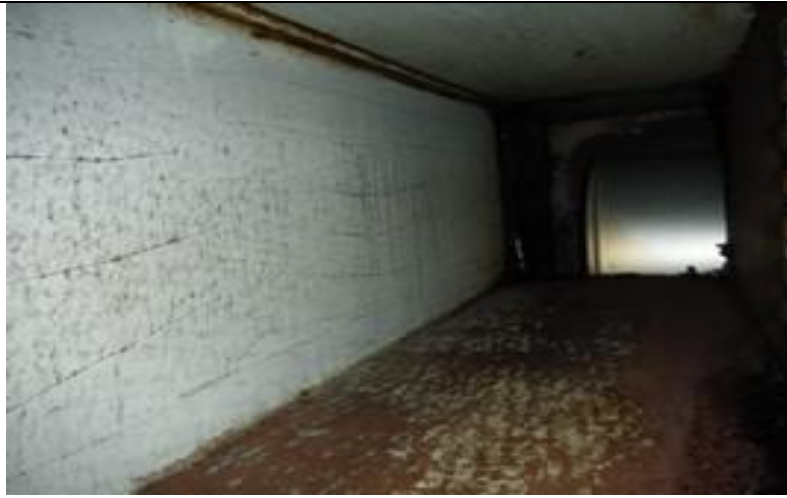
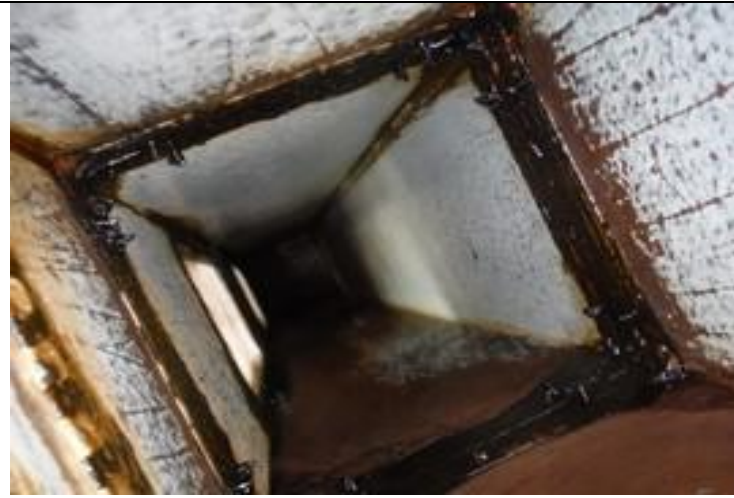
| Micron details | | Before | after |
|---|---|---|---|
| 4.DUCTWORK MIDWAY BETWEEN CANOPY AND FAN: | | 200 | 50 |

4. Ductwork Midway Between Canopy and Fan Before

4. Ductwork Midway Between Canopy and Fan After

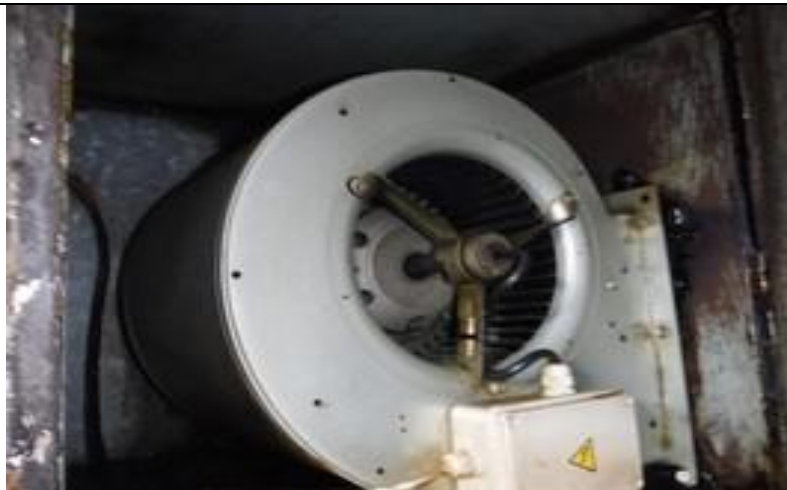
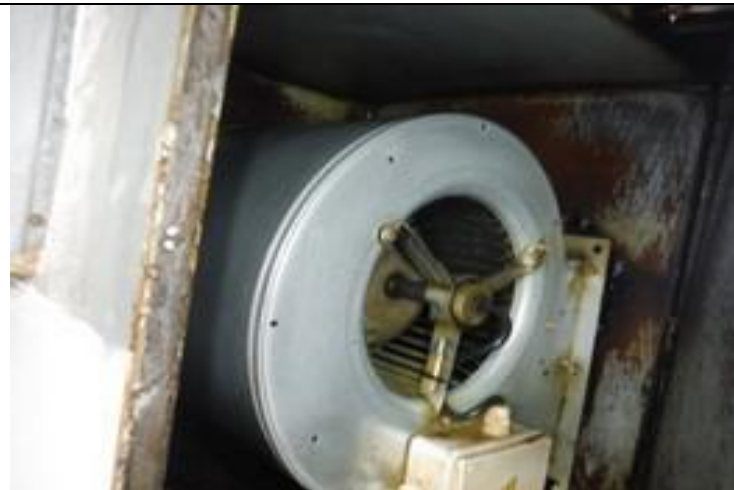
| Micron details | | Before | after |
|---|---|---|---|
| 6.FAN UNIT: | | 200 | 50 |

6. Fan Unit Before

6.Fan Unit after

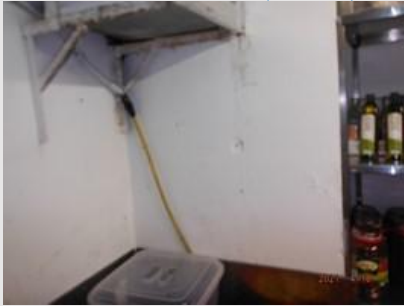
Picture taken from previous cleaning

**BASEMENT KITCHEN EXTRACT** – SYSTEM CLEANED UP TO FAN SECTION, VERTICAL DUCT (BRICK) IS CURRENTLY NOT ACCESSIBLE.

BUILD UP OF GREASE WITHIN INNACCESSIBLE SECTIONS OF DUCTING POSES A POTENTIAL FIRE RISK, TO RESOLVE THIS EITHER THE SYSTEM NEEDS TO BE REDISIGNED OR STRUCTURE OF THE BUILDING MODIFIED.
