# KITCHEN GREASE EXTRACT REPORT

Customer Name: Non Restaurant, 39 Holloway Road, N7 8JP, London

DATE OF CLEAN: 17.01.2025

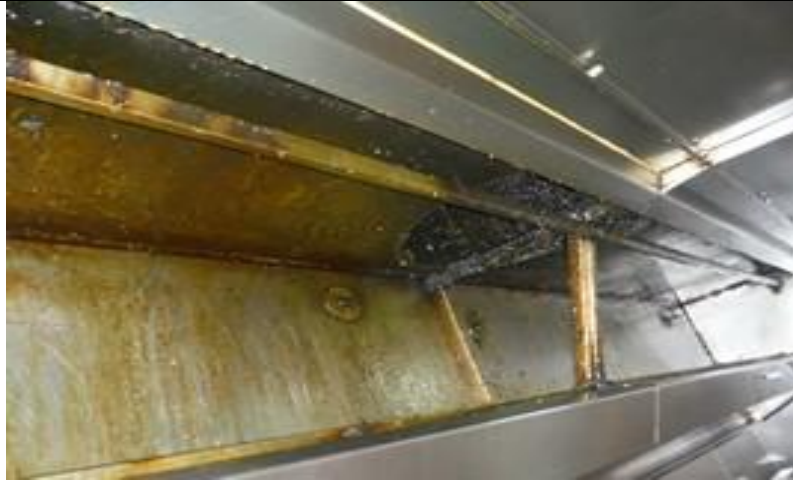
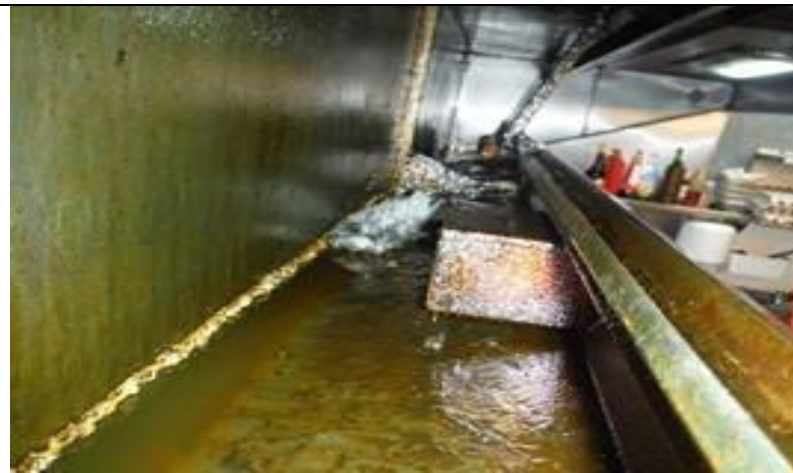
1 Canopy plenum (Main Extract)before

1. Canopy plenum (Main Extract)before

| Micron details | | Before | after |
|---|---|---|---|
| 1.CANOPY/EXTRACT PLENUM BEHIND FILTERS: | | 500 | 50 |

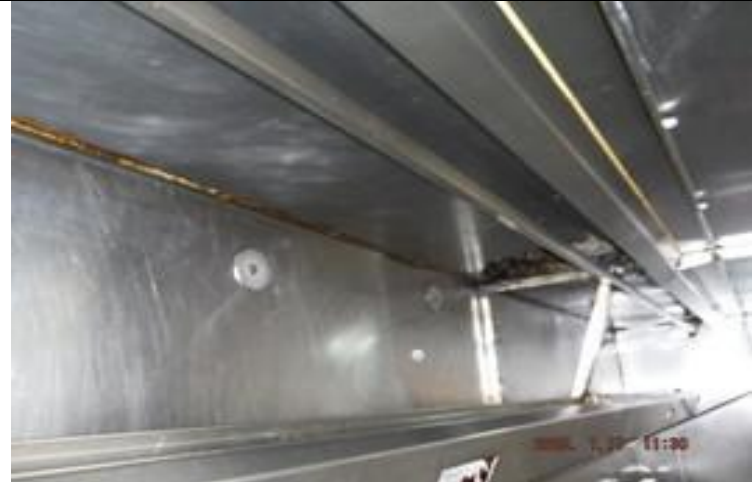
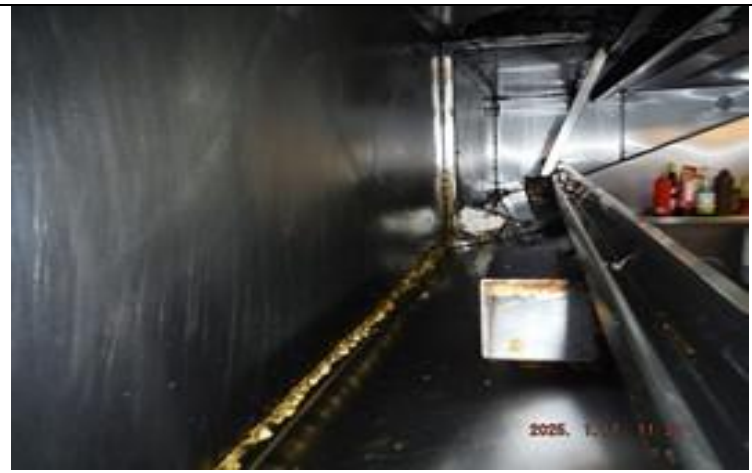
1 Canopy plenum (Main Extract) after

1. Canopy plenum (Main Extract) after

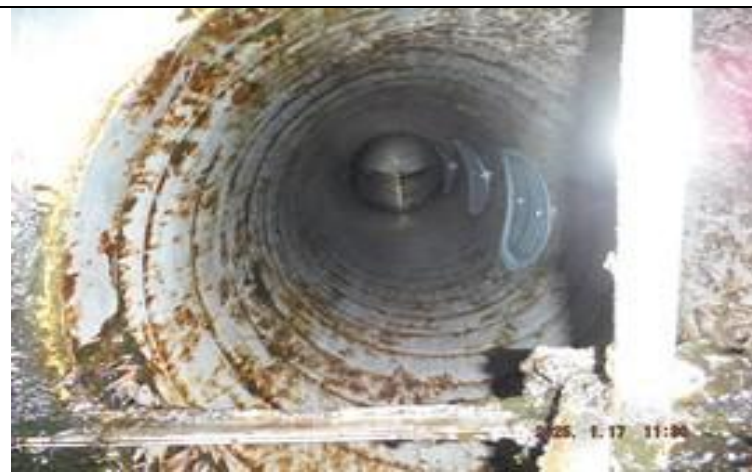
2. Ductwork 1M from canopy after

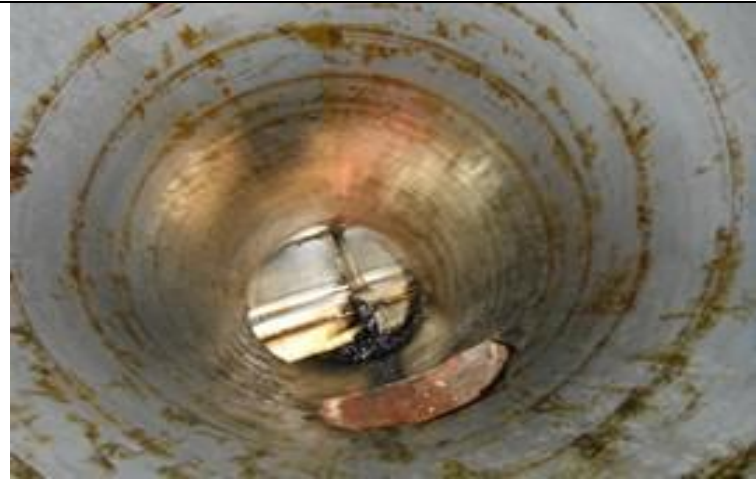
3.Ductwork 3M/midway from canopy after

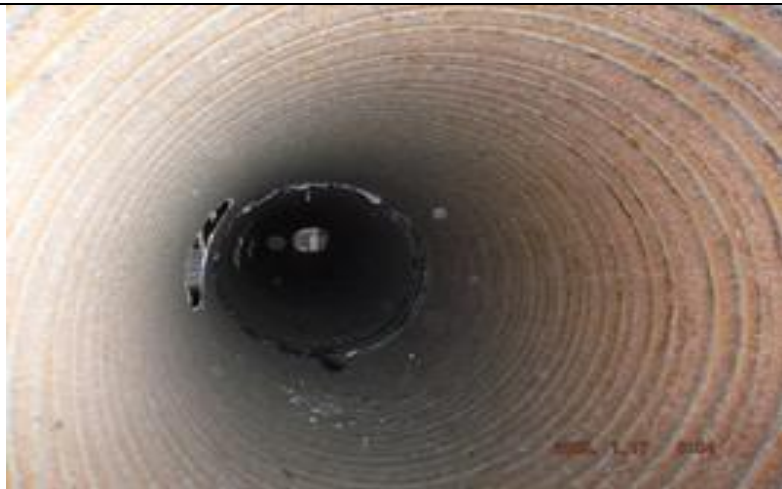
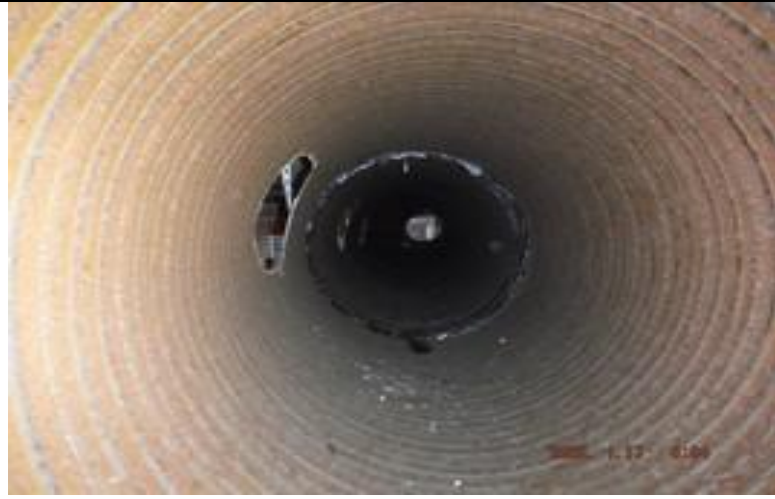
4. Ductwork Midway between canopy and fan before

| Micron details | | Before | after |
|---|---|---|---|
| 4.DUCTWORK MIDWAY BETWEEN CANOPY AND FAN: | | 400 | 50 |

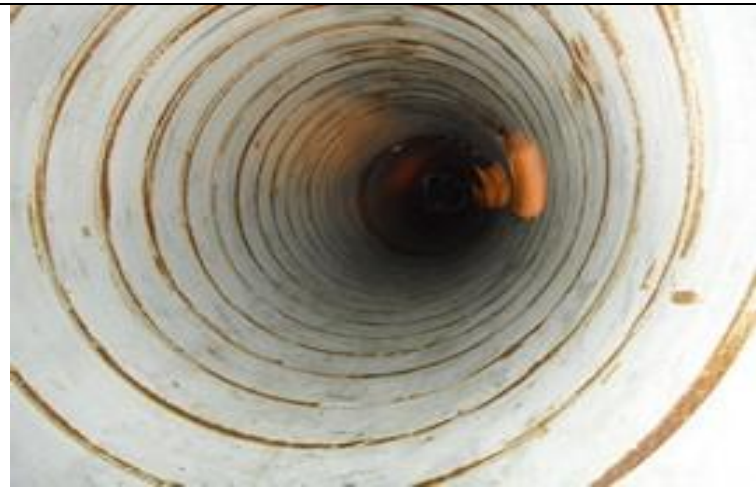
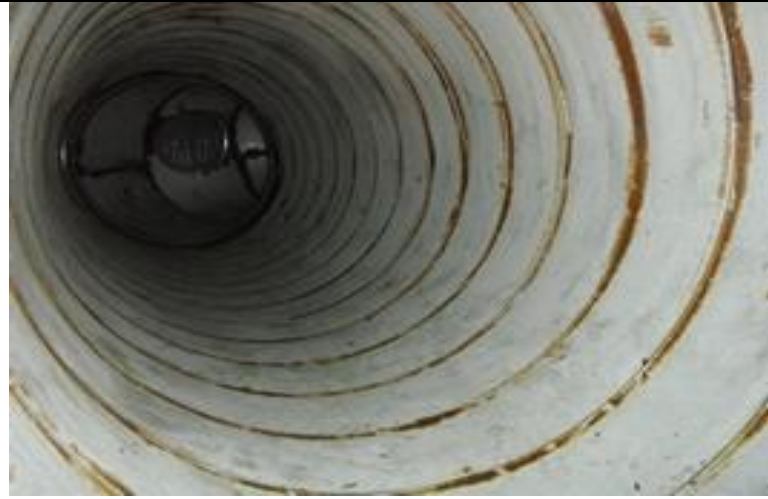
4. Ductwork Midway between canopy and fan after

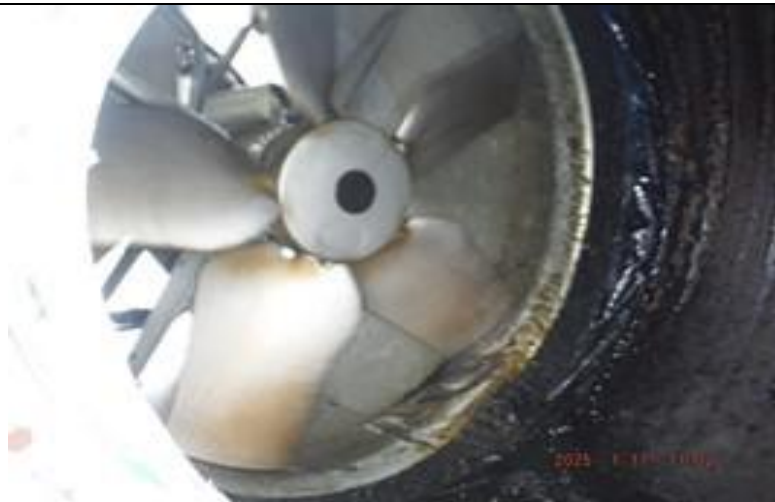
5. Duct upstream of fan before

| Micron details | | Before | after |
|---|---|---|---|
| 5.DUCTWORK UPSTREAM OF FAN UNIT: | | 350 | 50 |

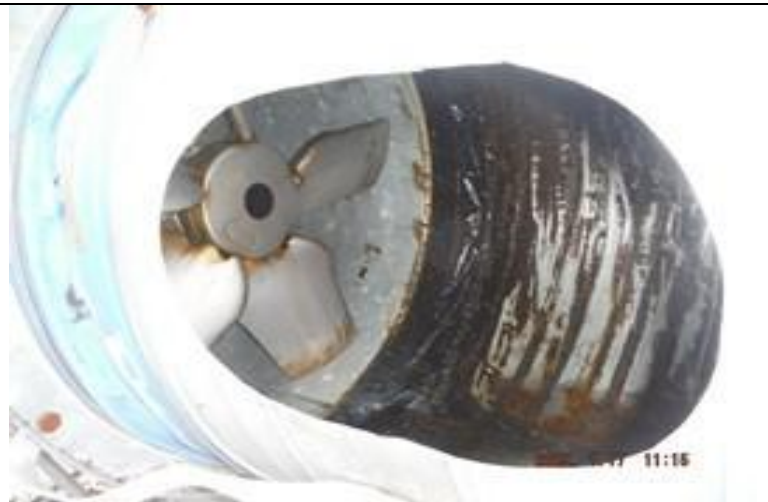
5. Duct upstream of fan after

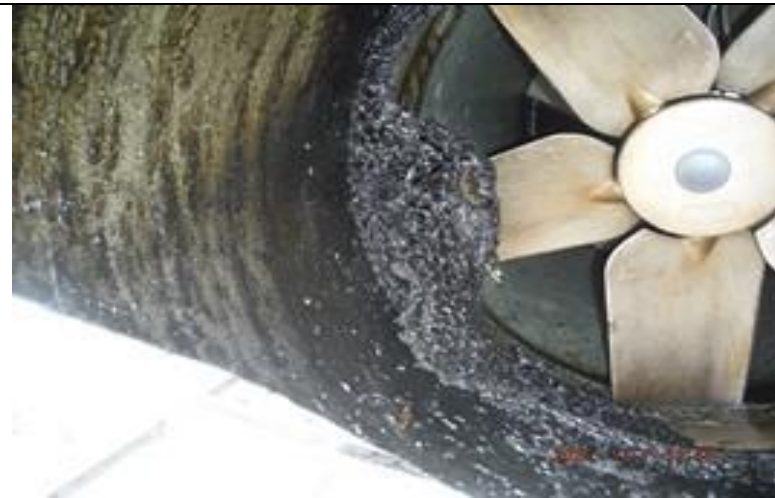
6. Fan before

| Micron details | | Before | after |
|---|---|---|---|
| 6.FAN UNIT: | | 300 | 50 |

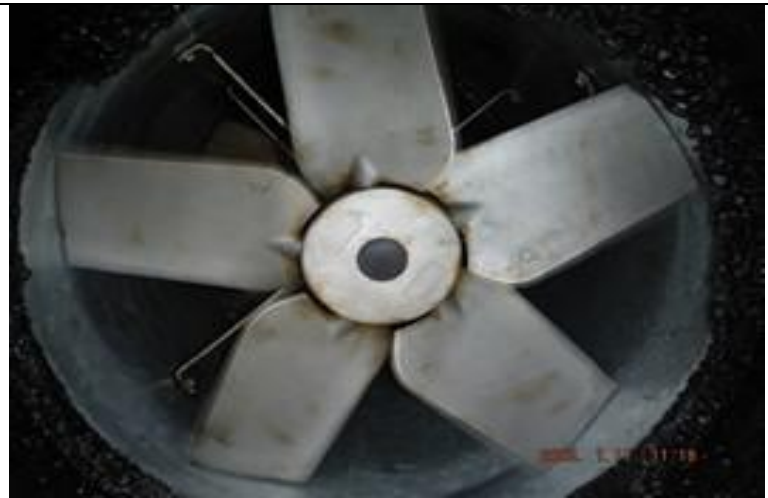
6. Fan after

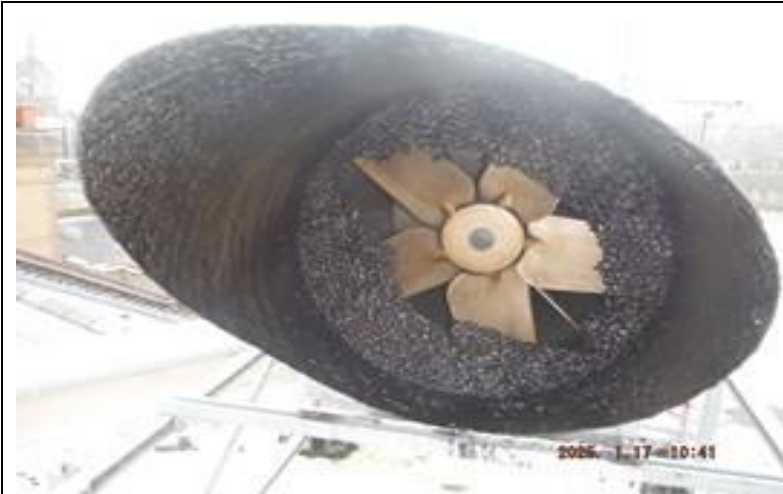
7 Duct downstream of fan before

| Micron details | | Before | after |
|---|---|---|---|
| 7. DUCTWORK DOWSTREAM OF FAN | | 250 | 50 |

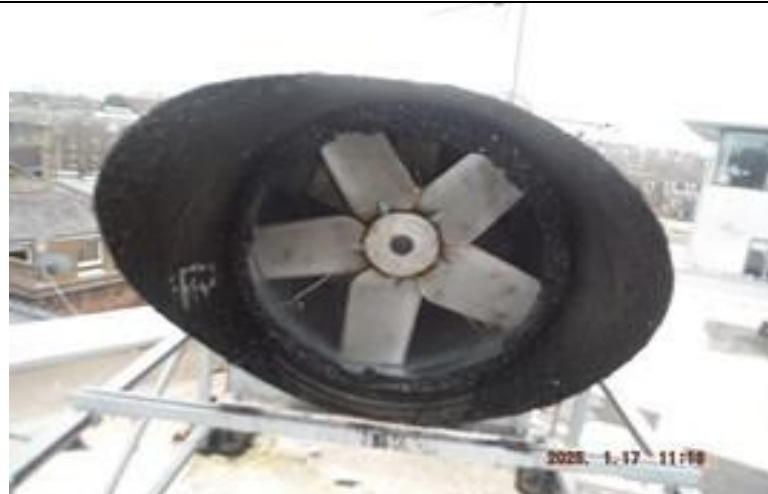
7 Duct downstream of fan after

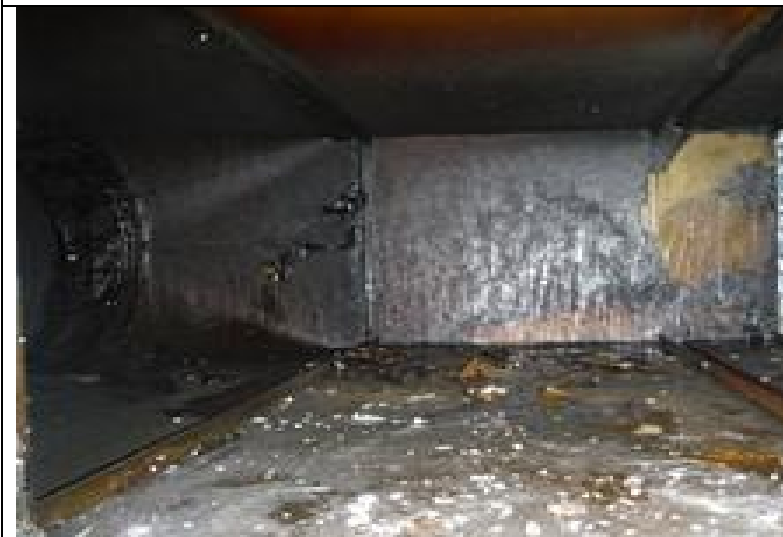
Filter box before

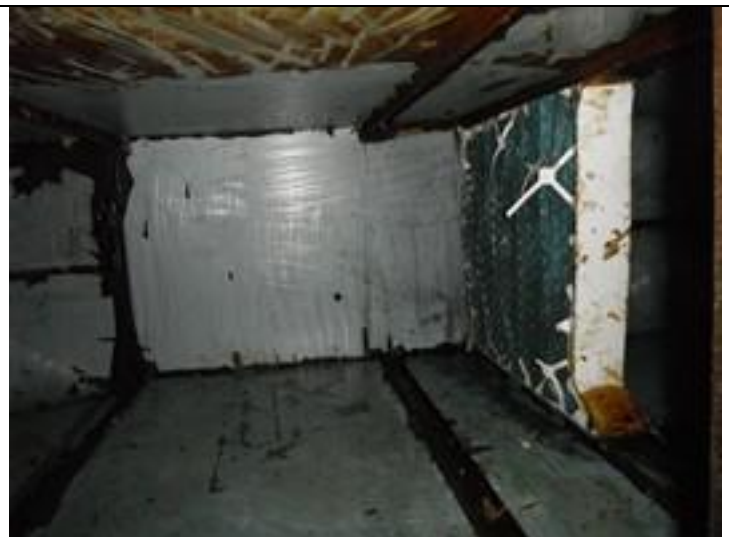
Filter box after

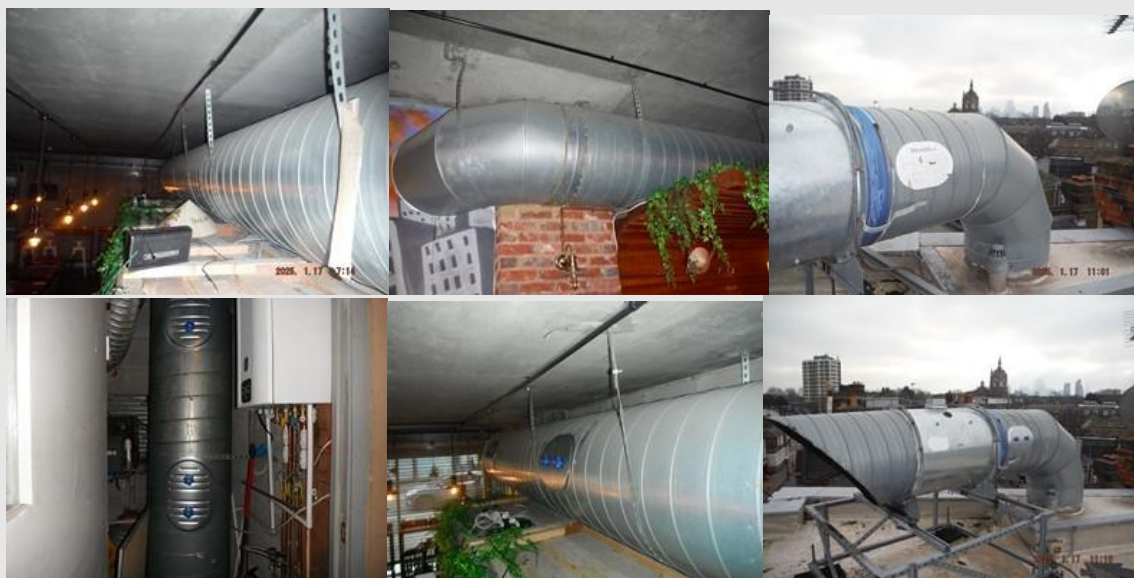
9 ACCESS PANEL INSTALLED IN THE SYSTEM

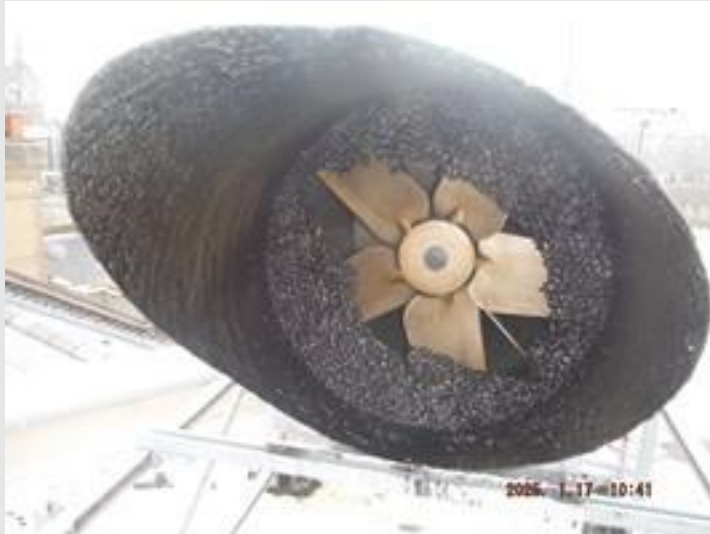
ANY LEAKS OR DAMAGE OF THE SYSTEM?: YES ( GRILLE SECTION REQUIRES REPLACING)

PICTURE SHOWS GRILLE SECTION REQUIRES REPLACING

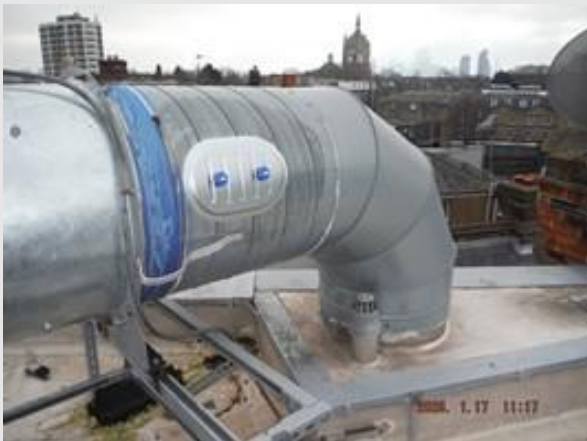
PICTURE SHOWS DUCT DROPS DOWN INTO THE RISER SHAFT - FUTURE INSPECTION REQUIRED WITH MANAGEMENT OF THE BUILDING TO CHECK IF RISER IS ACCESSIBLE FOR CLEANING
